Development of a framework for sustainable repair of adobe building in an urban area in Nigeria

**DEVELOPMENT OF A FRAMEWORK FOR SUSTAINABLE REPAIR OF
ADOBE BUILDING IN AN URBAN AREA IN NIGERIA**

School of Architecture, Design and the Environment

April 2012

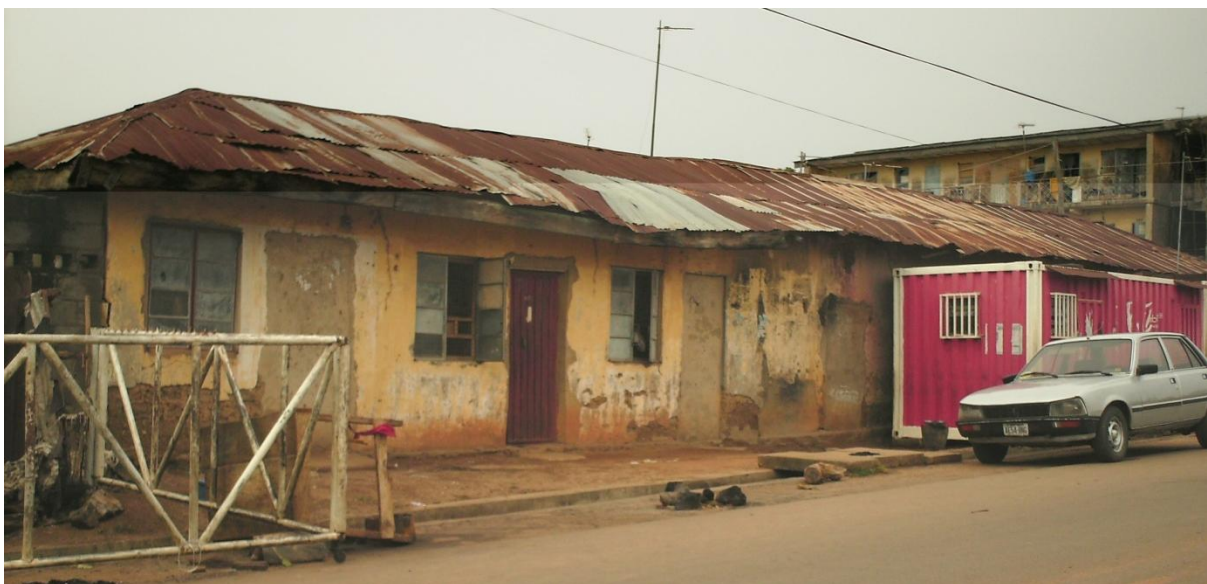
Inappropriate repair could be the reason for the leakages in the other 2 compounds. It was noticed in these 2 other compounds that some of the roofing sheets have been replaced recently with new ones but the leakage still persists. The difference between the old and new roofing sheets can be distinguished from the physical appearance of the two. The old sheets have corroded, while the new once are still shining (see figures 4.9 and 4.10).

Figure 4.9: Adobe building with sagged roof, replaced roofing sheets, two sealed doors and cement based rendering. Note also the steel container use as part the building extension.

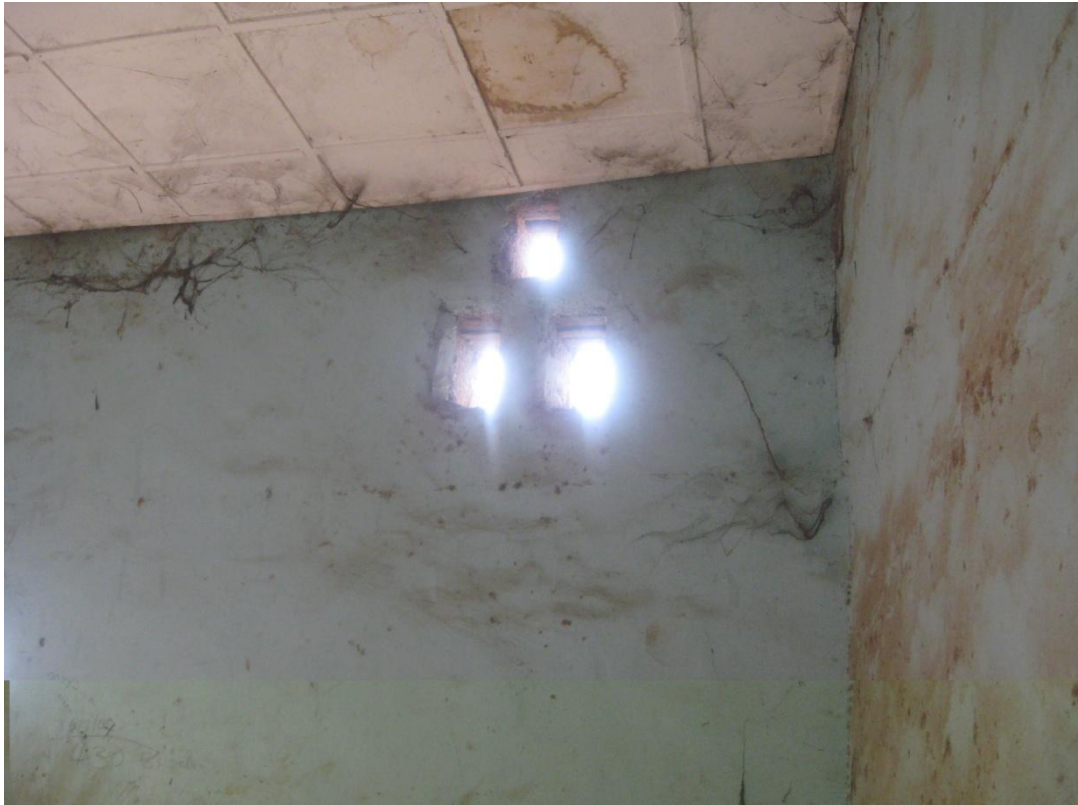
Figure 4.10: Interior of a house with leaking roof. Note the stained ceiling cause by the leakage

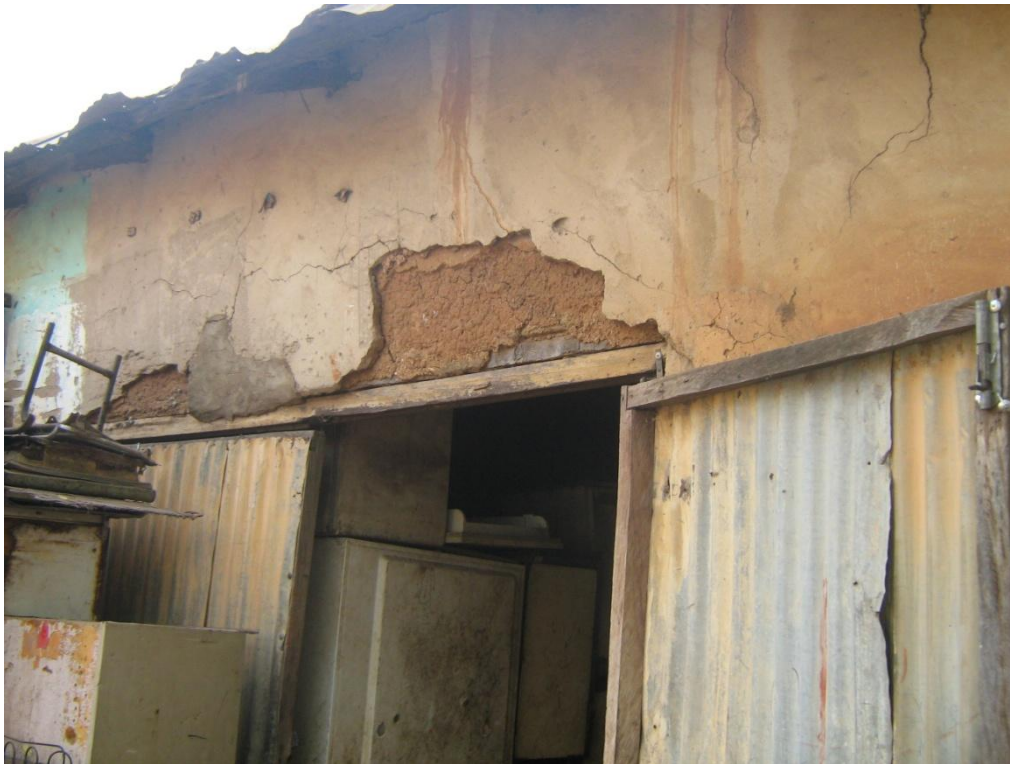
Traditionally, arches were introduced on openings wider than 900mm (Dmochowski, 1990, vol. 1:1.24). Openings in the adobe buildings in Sabon Gari were therefore originally limited to 900mm. However, the spans of the lintels were increased during the remodelling, because shops and other commercial activities require wider doors. The original doors were therefore replaced with wider ones of between 1200 and 2400mm widths and the *azara* replaced with timber lintels. The resultant effect of this action is the bending of timber lintels due to the use of under size timber and excessive point loadings (see figure 4.11).

Figure 4.11: A partially deformed timber lintel caused by excessive loading. Note the cracked cementitious rendering

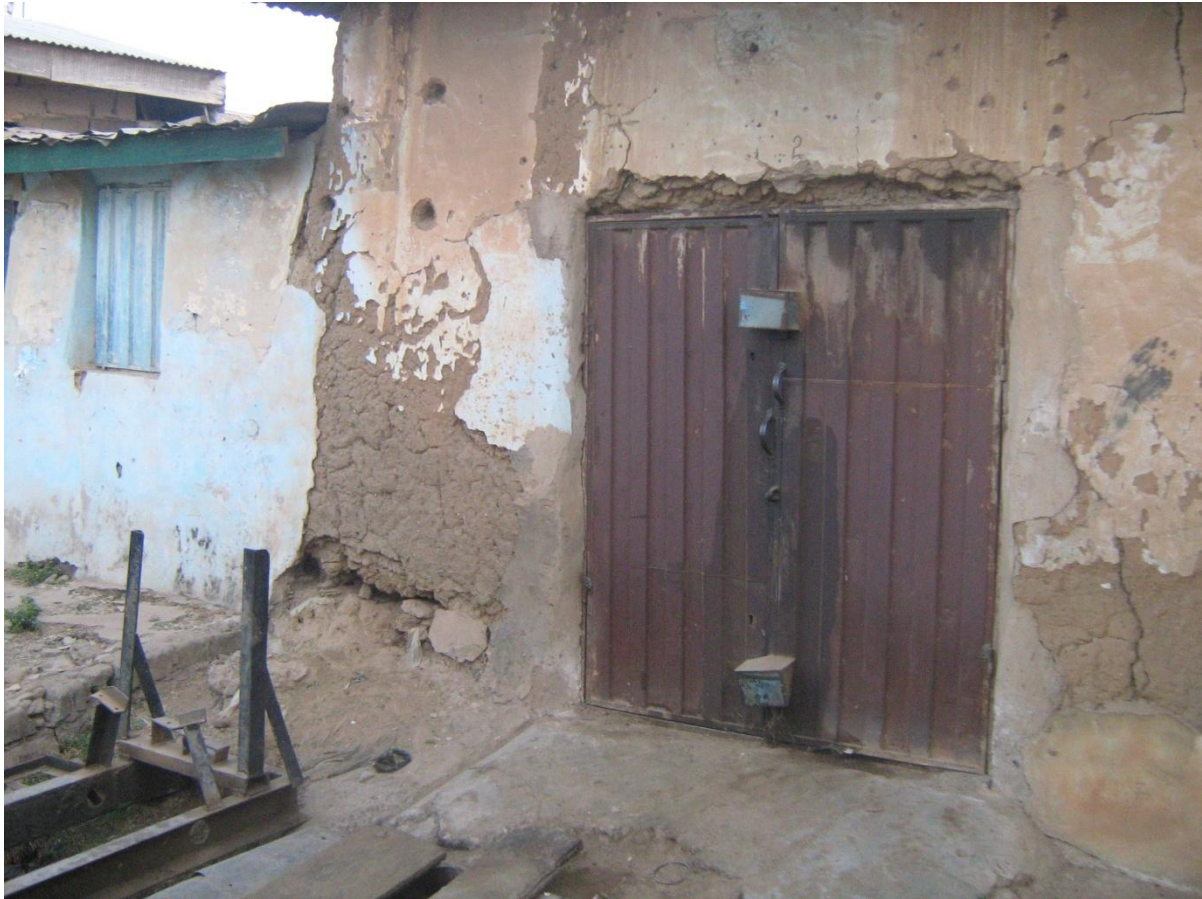
I. Basal erosion: 17 of the 20 compounds surveyed have their buildings are affected by erosion at the base of the walls. This erosion is accelerated by the cementious render in all the 17 buildings. The erosion in 14 out of these 17 buildings is caused by rain water from the roof as a result of lack of guttering (which is not common in Nigeria) and the lack of appropriate drainage system (see figure 4.12). The other 3 compounds with buildings not affected by basal erosion have external earth render. In fact 2 of these 3 compounds have both internal and external walls rendered with earth. This confirms that cementious render accelerates the rate of erosion on the wall base of these buildings.□

Figure 4.12: Accelerated basal erosion on adobe wall due to lack of drainage and the application of cementitious render

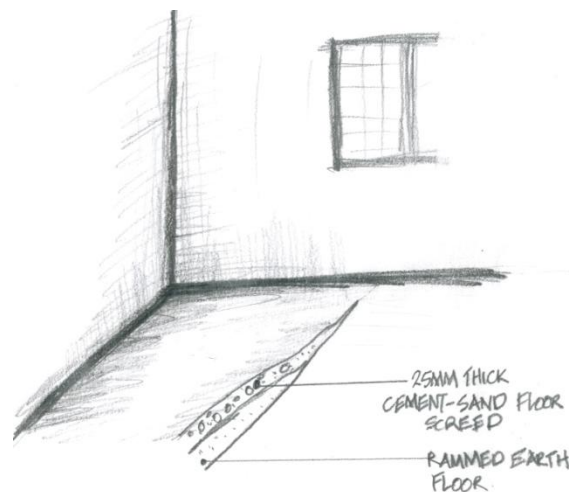
III. Floor cracks: All the 20 compounds surveyed have floors made from rammed earth hardcore and finished with cementious screed. Cracks were noticed in all the floors. The cracks are due to lack of strong flooring that could with stand wear and tear. The thickness of the cementious floor screeding in 3 buildings is just 25mm, while in another 2 the thicknesses are 35mm. The floor thickness of the remaining 15 buildings could not be ascertained because the cracks have not got through to the rammed earth hard core filling. Unfortunately, because of the restriction in photographing the interior of these buildings the floor defect can only be illustrated by the author as shown in figure 4.13. According to the occupants, the cracks have been patched up on numerous occasions, but continued to reappear.

Figure 4.13: Cracks on cementious screed floor of adobe building

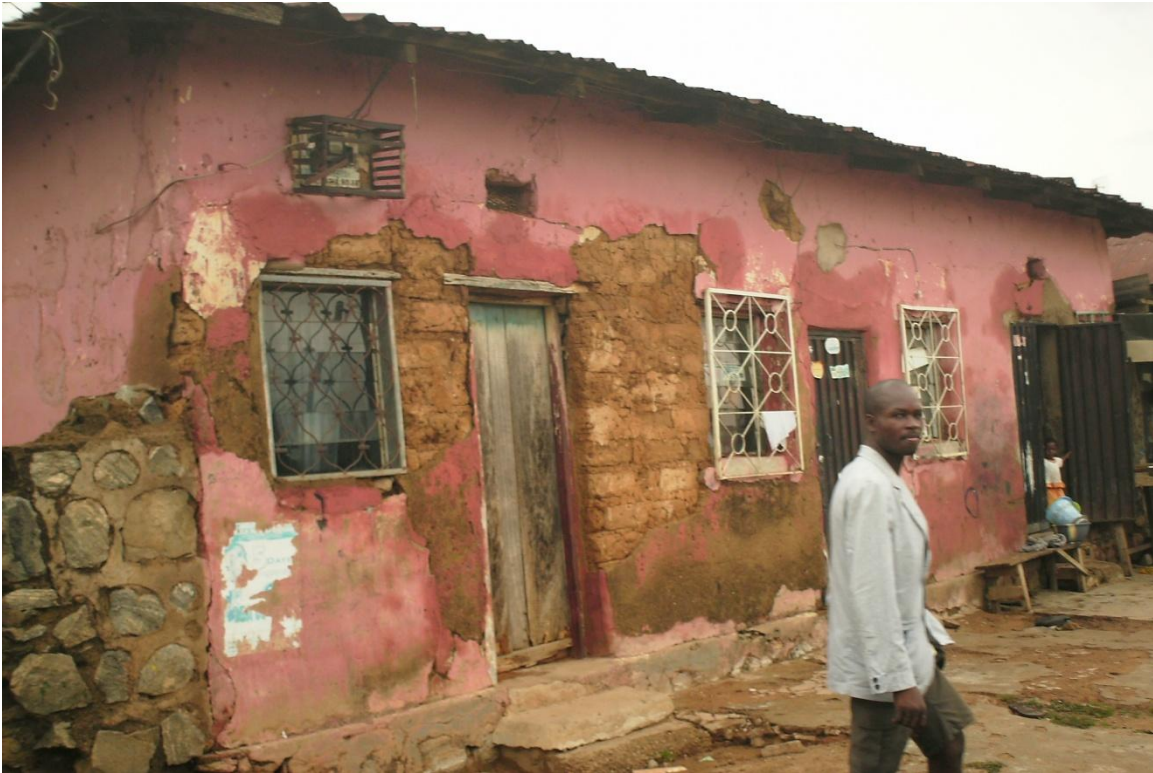
Figure 4.14: An adobe building with cementious rendering. Note the iron grills and the dampness on walls due to the rendering

I. Damp associated with wall signs: Telecommunication, food and beverages companies do advertise their products and services on walls of residential buildings. Many buildings not only those made from adobe in Sabon Gari carry these adverts, because of the high financial reward. 4 adobe buildings have these adverts. The walls were rendered with cement base material and painted to allow the advert to be written in oil paint. The effects of both cement base rendering and oil paints on adobe wall can be seen in figure 4.14 above.

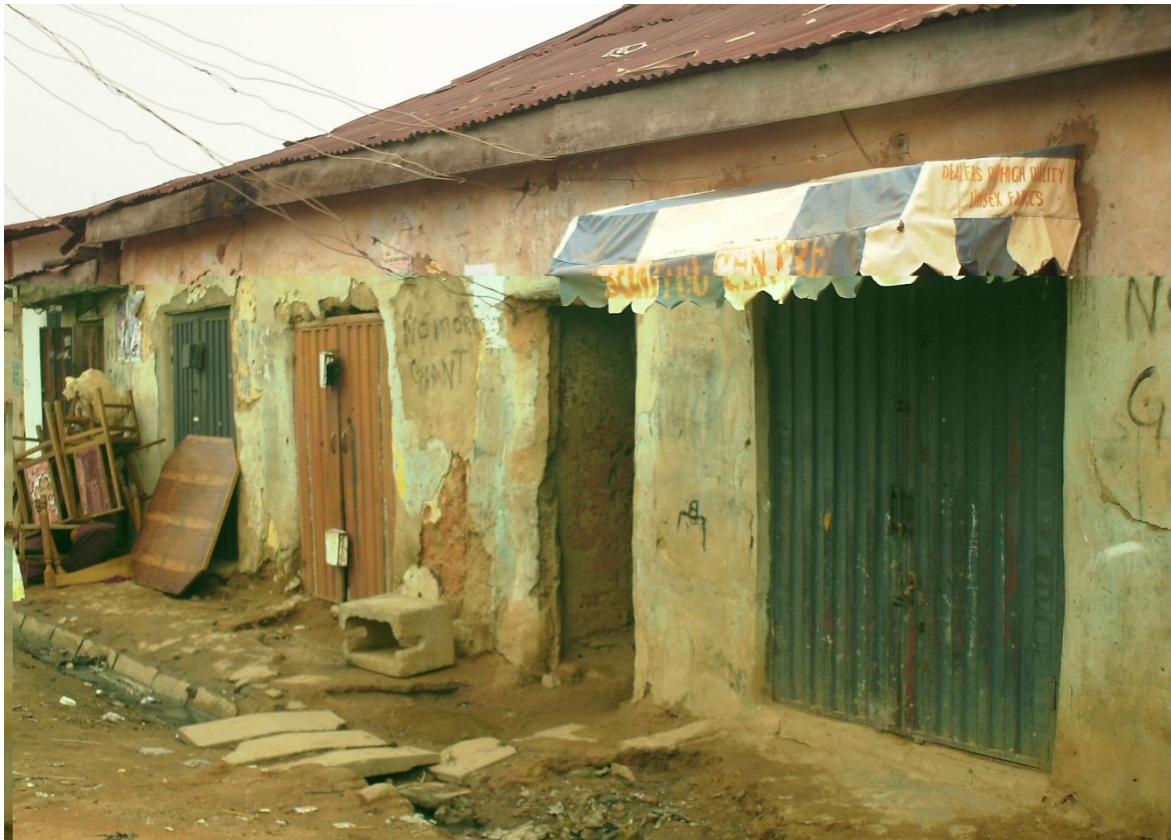
Figure 4.15: Adobe building with canopy, new doors, filled up window opening and new extension with lean-to roof at the far end

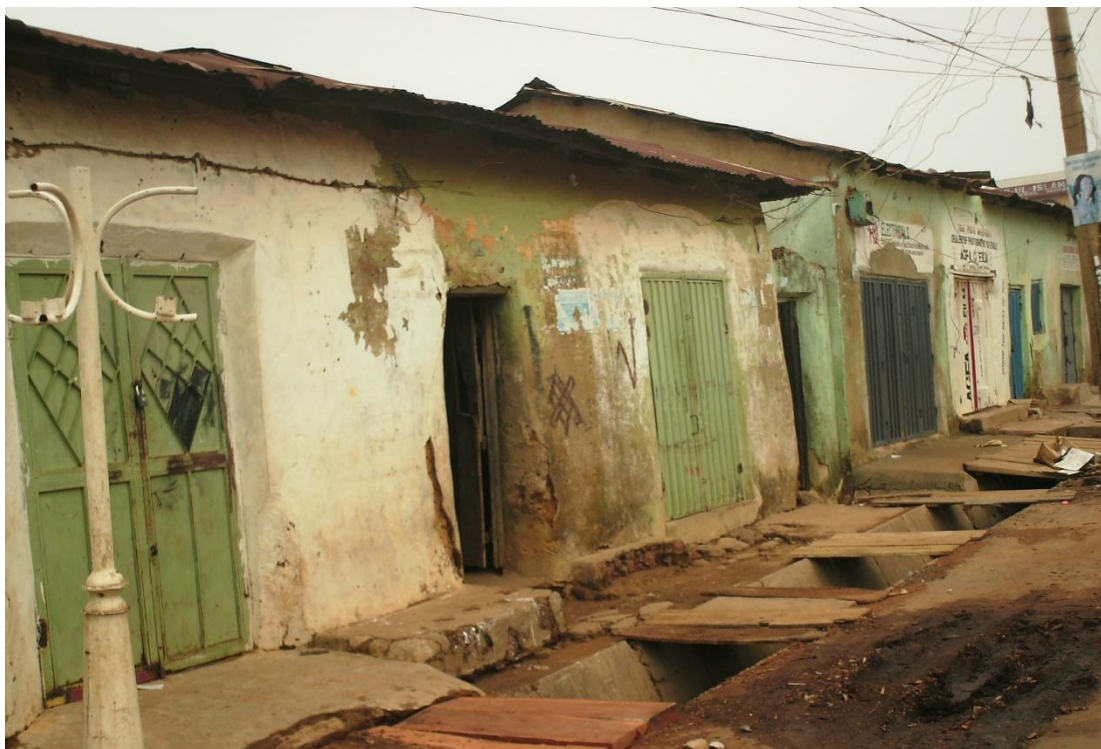
IIc. Wall cracks in areas where electrical appliances were introduced: The introduction of electrical fittings such as ventilation fans (mostly ceiling fans) and other appliances requiring new wiring, sockets, switches etc. usually accompanied remodelling and conversions. In the process of installing these electrical services, the adobe walls were hacked off and patch up with cementious mix. Cracks were noticed in 2 buildings in which electrical fittings were installed. This is not only an eye sore as can be seen in figure 4.16 below, but can affect the structurally stability of the adobe walls.

Figure 4.16: The effect of electrical installation and government services (road, drainage, etc.) on adobe buildings

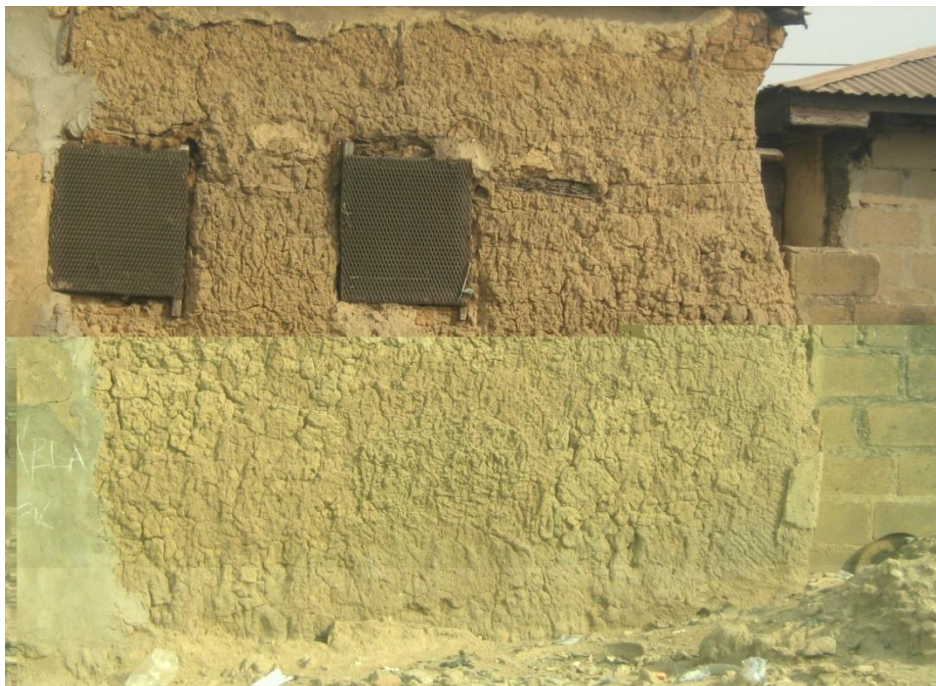
IV. Wall cracks by the burglary proof areas: In Nigeria security screens on windows are now compulsory in every building to make them burglary proof as can be seen in figures 4.14 and 4.17. Since these buildings were built when security screens were not a necessity, none of the 20 buildings had the security screens originally. But these were introduced according to the occupants in the 1990s when house burglary became too rampant in Kaduna. Patches of cementious mortar could be noticed in the areas where these burglary proofs screens were fixed to the walls in almost all the buildings and severe cracks caused by their introduction in 32 rooms in 12 compounds.

Figure 4.17: Adobe building with security screen on the windows

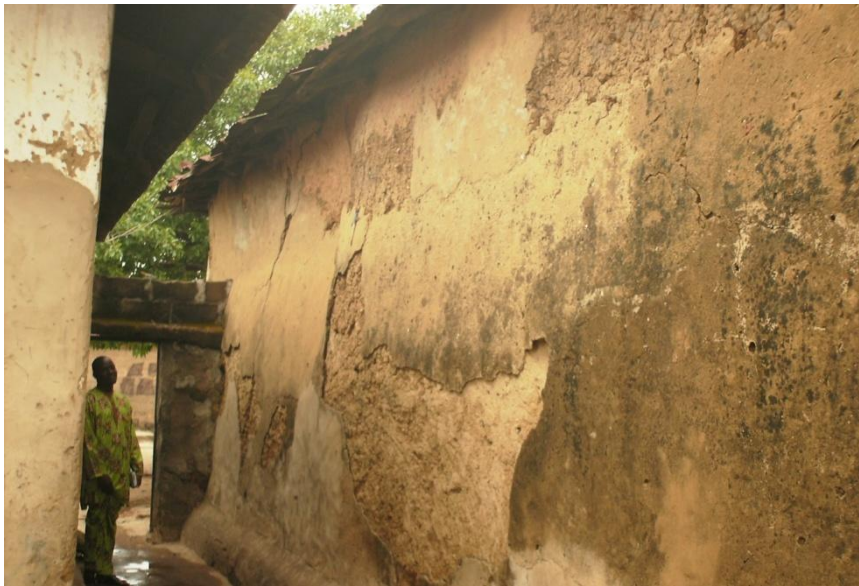
draining rainwater onto the adobe wall in another property (see figures 4.18 and 4.19). The rain water that drains on these buildings causes accelerated erosion of the adobe walls.

Figure 4.18: Roof of adjoining property affecting adobe wall in another property

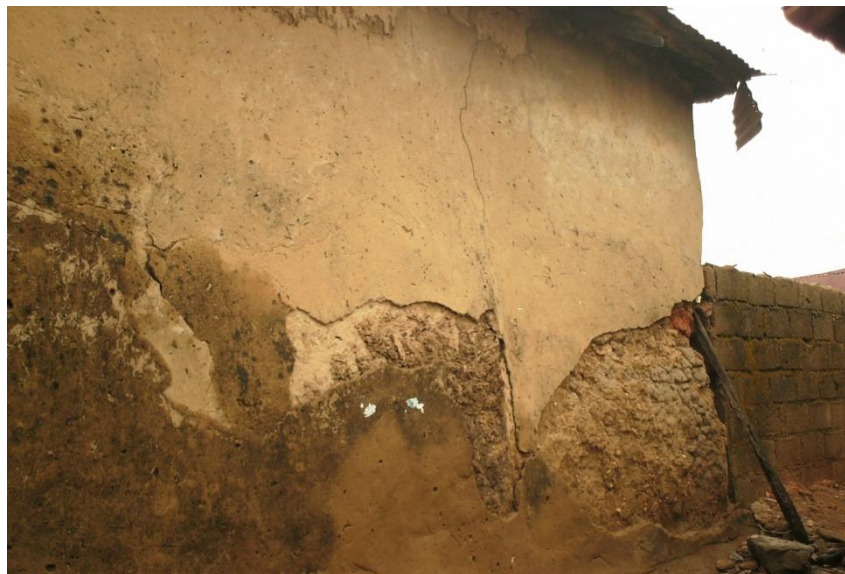
Figure 4.19: This picture is of the same building above (figure 4.16) but taken from the opposite side. The effect of rain on the adjoining property is clearer from this view

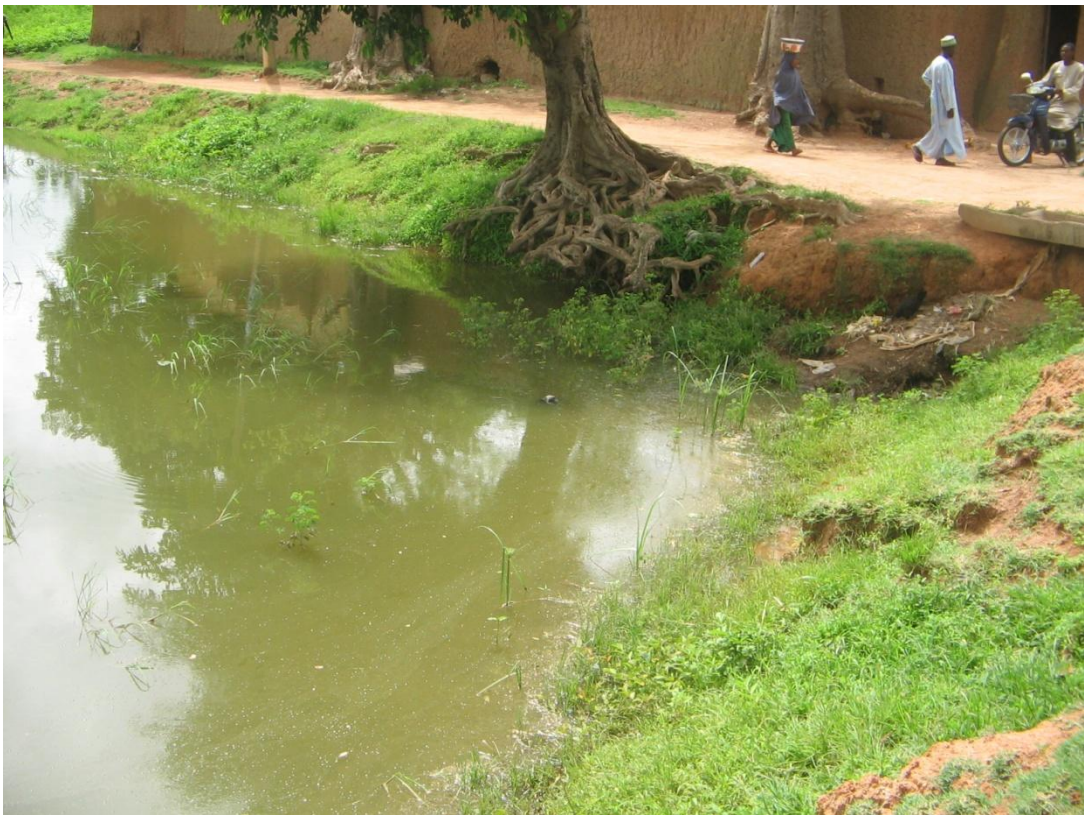
Figure 5.8: An eroded burrow pit, which is already a threat to the adjoining adobe buildings

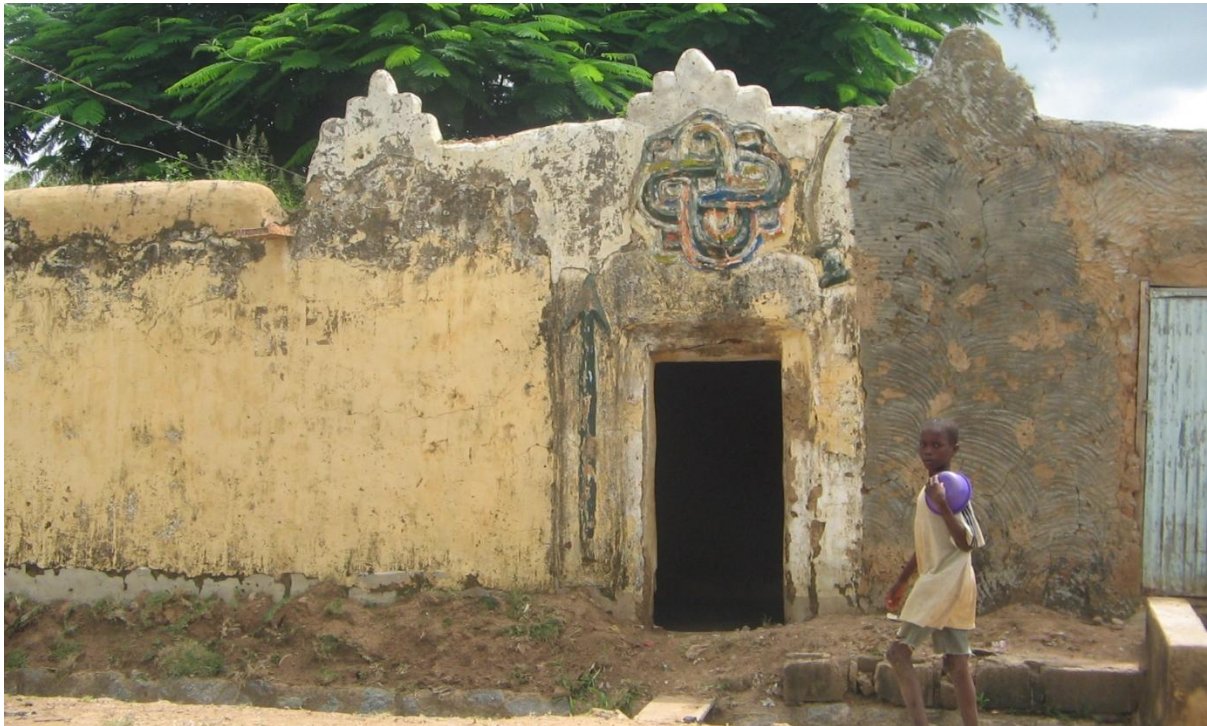
Figure 5.20: A dilapidated adobe building with cementious render

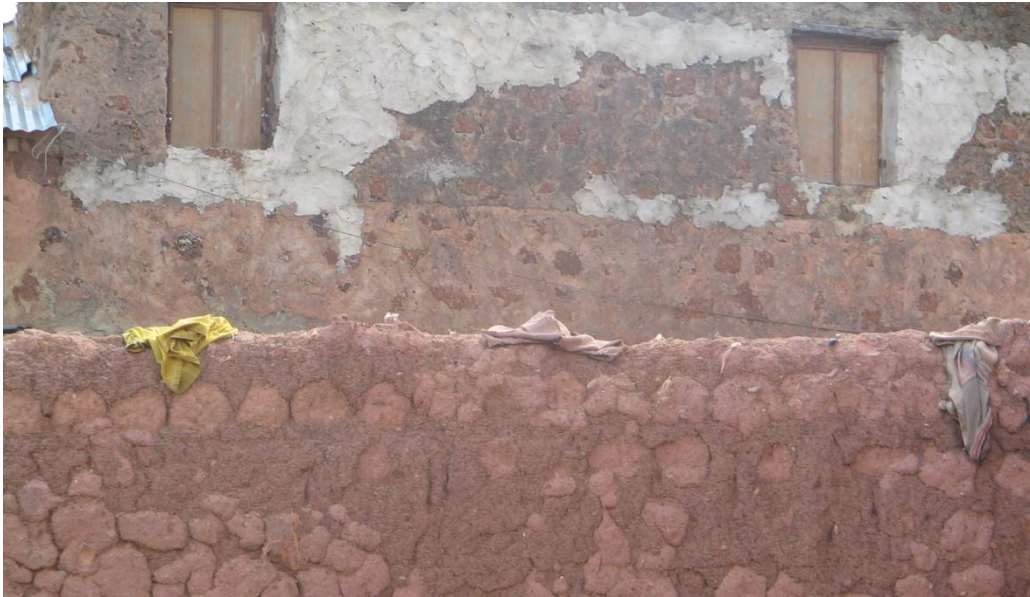
Figure 5.21: A cracked cementitious render on adobe wall

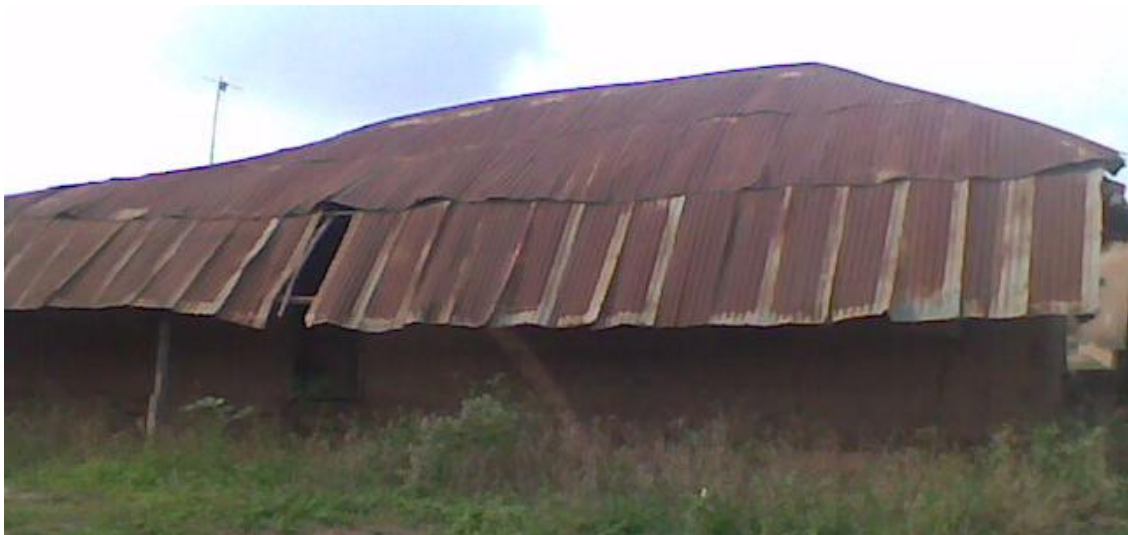
Figure 5.27: An abandoned cob building in Offa

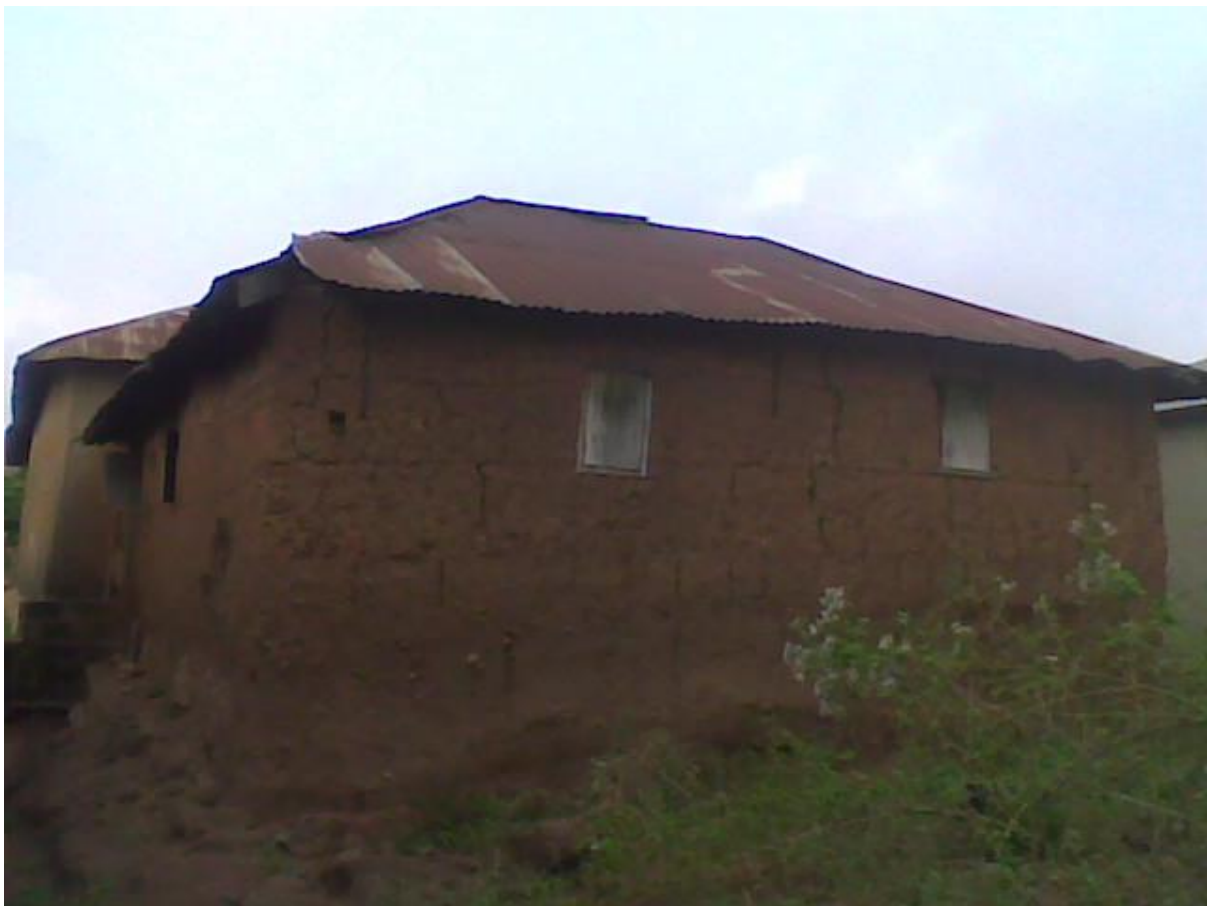
Figure 5.29 Cob buildings with cracks between lifts

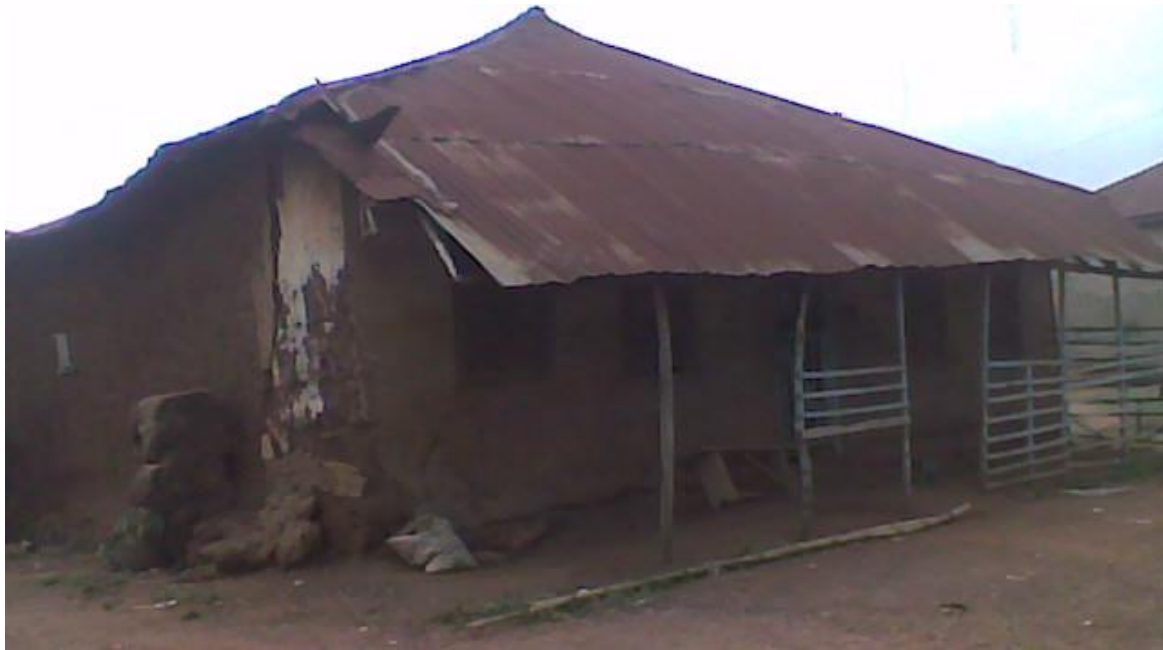
Figure 5.30: A cob building with vertical crack

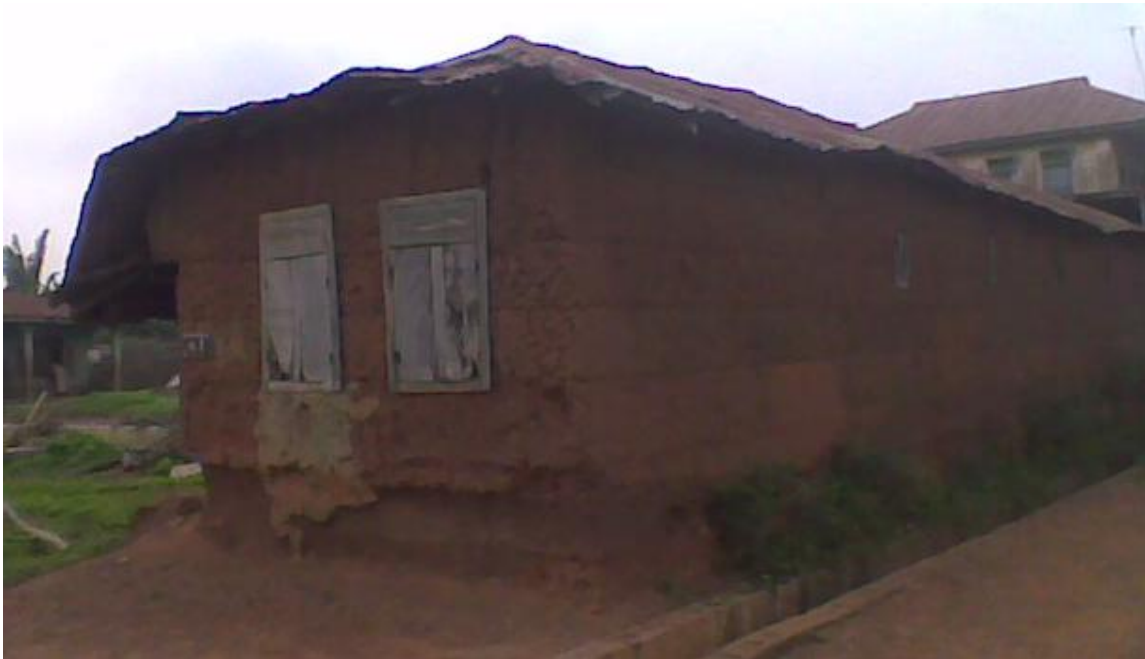
Figure 5.31: Basal erosion on a cob building in Offa

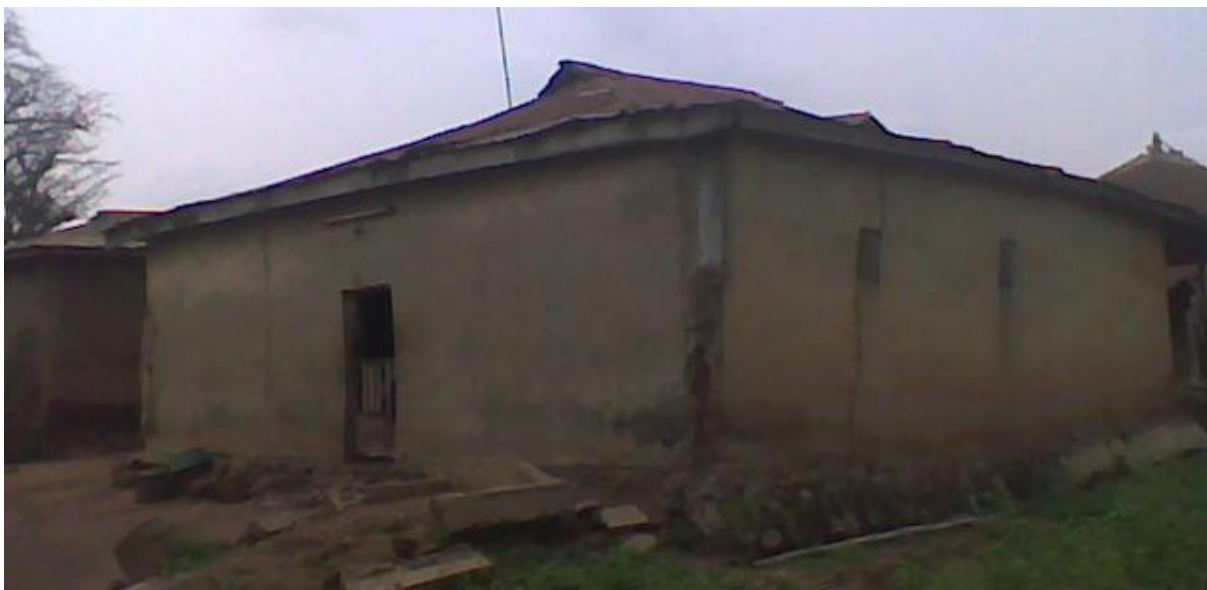
Figure 5.32: Cob building with cementitious render and stone plinth bonded with cementitious mortar

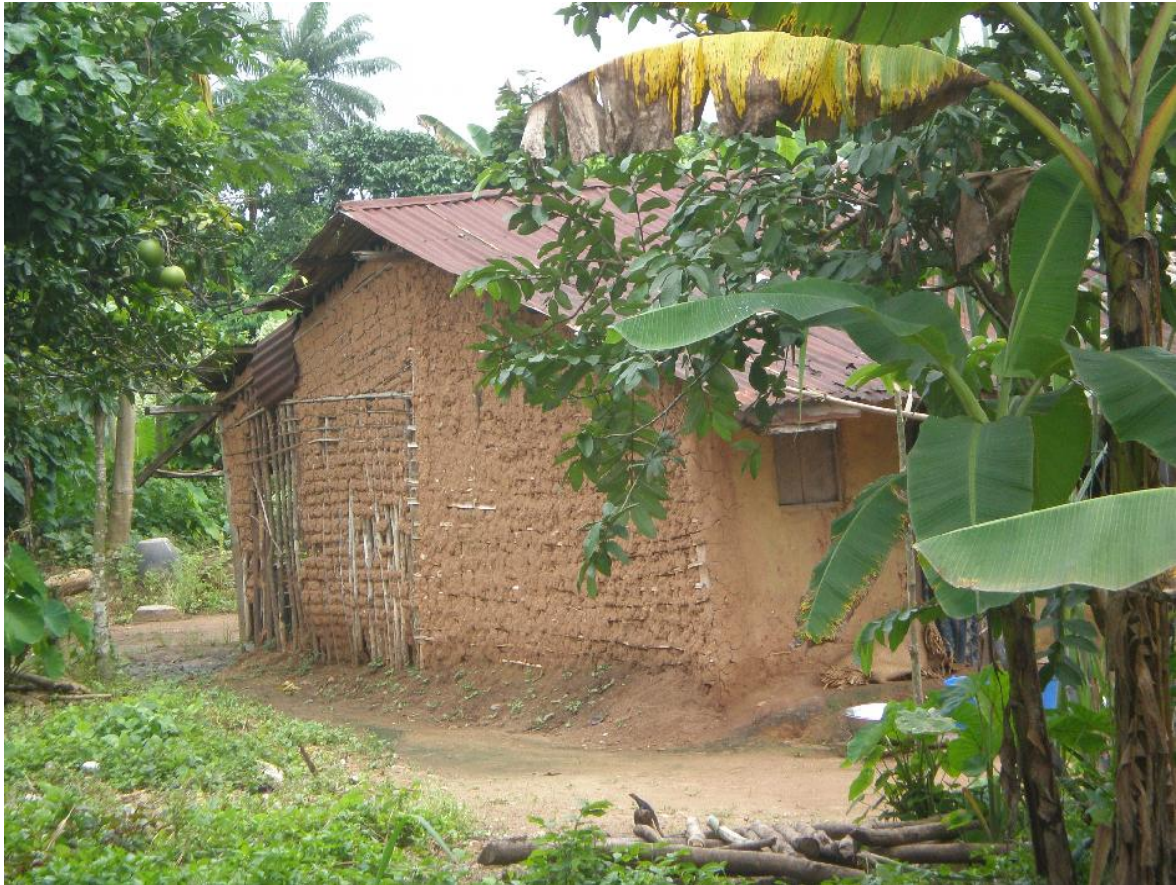
Figure 5.34: An eroded wattle and daub
