Landsliding on the south east coast of the Isle of Wight: nature, characteristics and causes

The Plymouth Student Scientist
University of Plymouth

Grant Cole

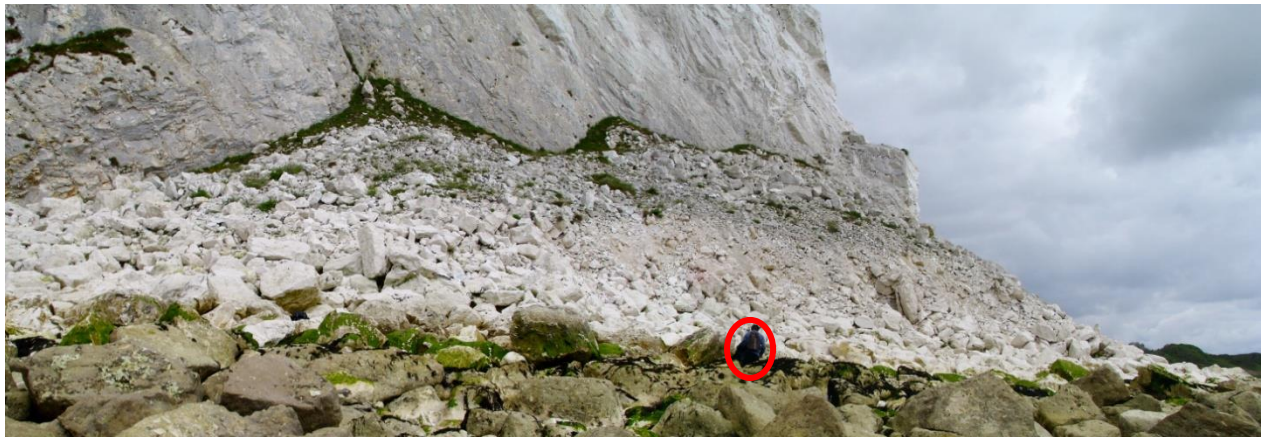
Figure 3.1 Rock fall (2) at Culver down (Whitecliff), person circled in red for scale.

The Fall type landslides seen at Culver Down (Whitecliff) (Figure 3.1 & photo 3, Figure 3.12) show an accumulation of rocks at the base of the cliff / slope, which can vary in size (see landslide inventory; appendix C). The flow type landslides in Whitecliff Bay have a typical channel shape to them which then expands at the front in a lobate structure (Figure 3.2). Complex landslides with flow as the main movement types are similar but due to there being many converging flows the lobate form is lost for this particular landslide (Figure 3.3).

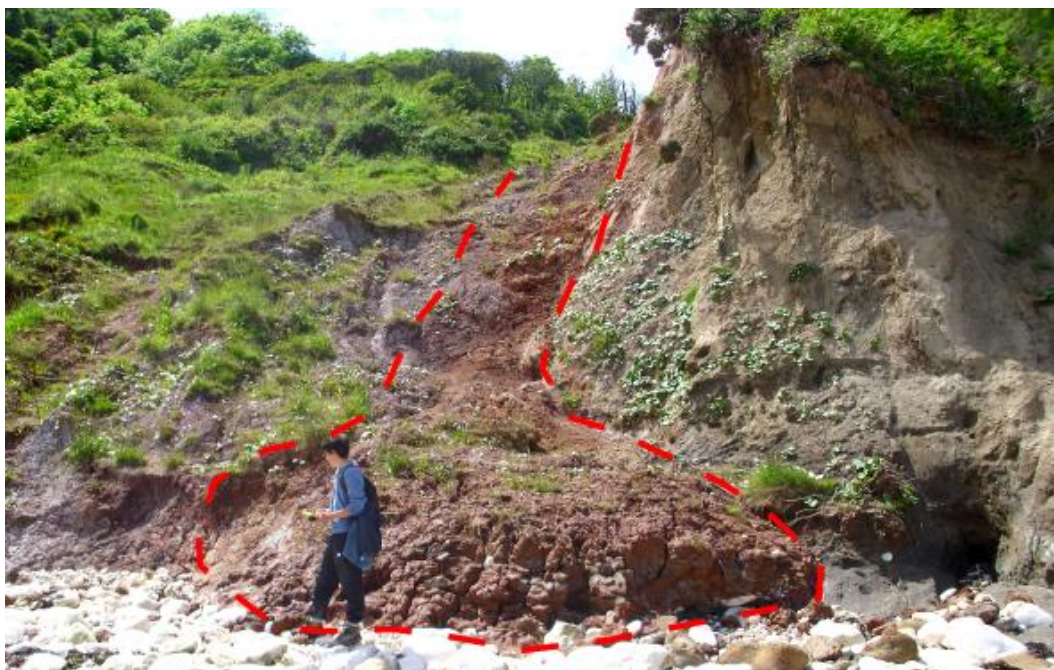
Figure 3.2 Flow type landslide (6) in Whitecliff Bay (south), person for scale.

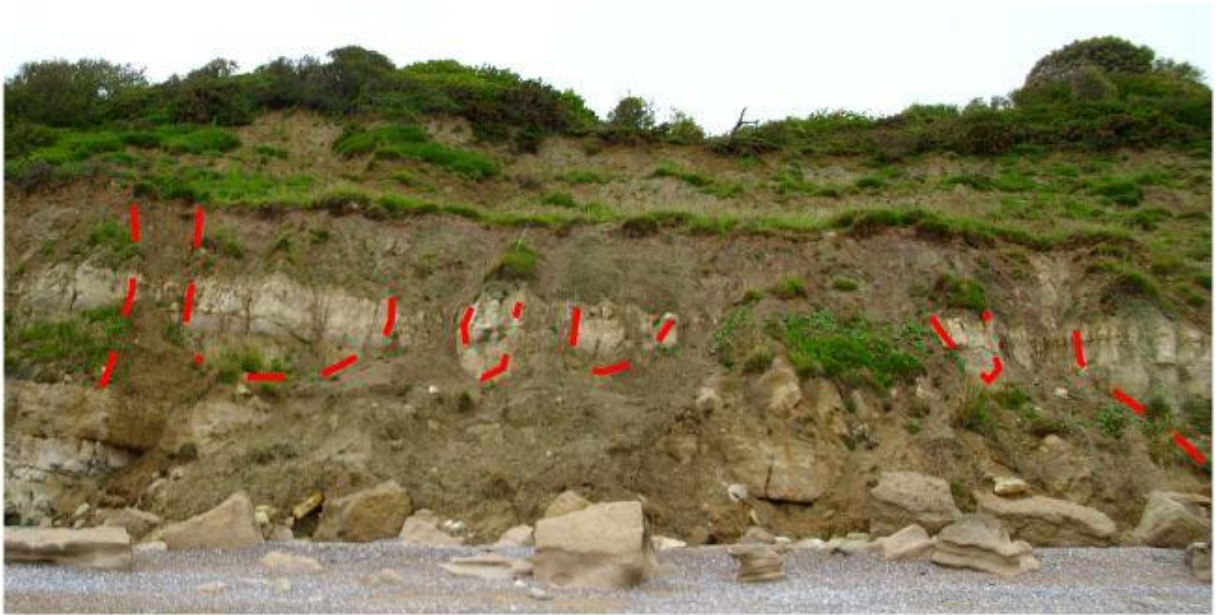
Figure 3.3 Complex landslide with main type of movement (25) being flow type (Whitecliff Bay).

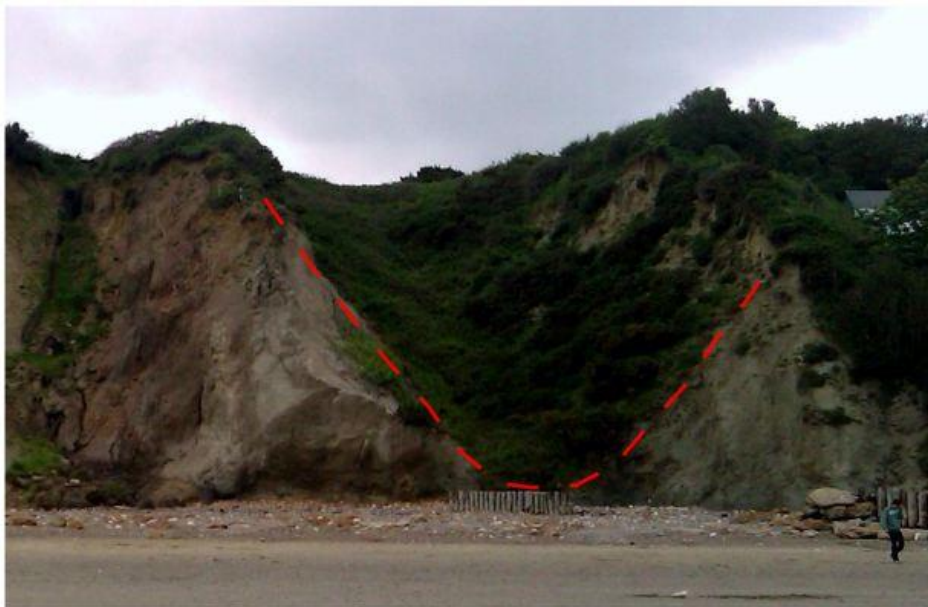
Figure 3.4 Cross-sectional shape of a Translational (planar) landslide (16) in Whitecliff Bay (south).

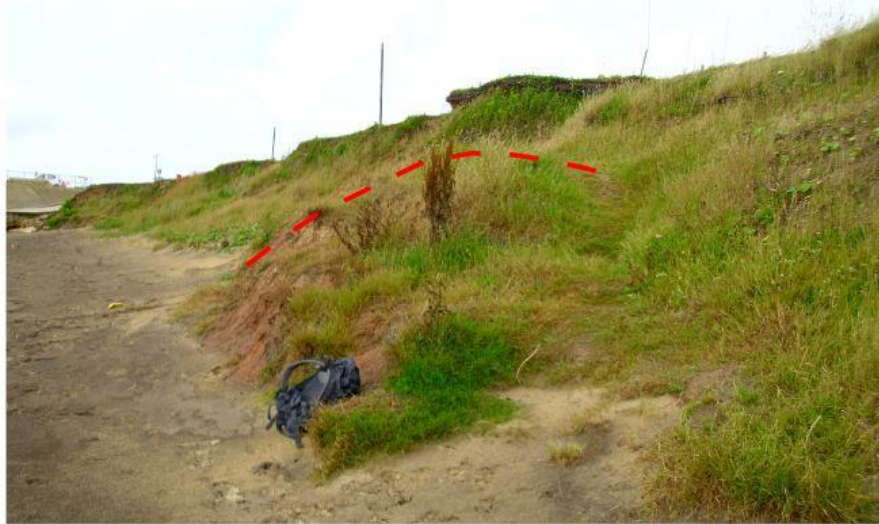
Figure 3.5 Shallow single rotational landslide (1) at Yaverland. 40L back pack for scale.

The single rotational slides in Sandown Bay have a similar form to the ones in Whitecliff with a mound shape created at the front of the landslip (Figure 3.5) and a distinct back scar as seen on a complex landslide that has a rotational slide as the main movement type (photo 9, Figure 3.11).

The single rotational slides in the area show typical hummocky features (Figure 3.5) caused by the rotation of the displaced mass along a curved rupture surface (Cruden and Varnes, 1996). These hummocks were also picked out by the profiles (Figure 3.9), shown by the convex part of the profile. The single rotational slides are shallow failures when cliff heights are relatively low but get increasingly deeper seated with larger run outs and offsets as cliff height increases (Figure 3.18-3.21). There is a strong relationship in the data shown by the R^2 values but the strongest relationship can be made between cliff height and vertical offset as there is only about a 10% chance that other factors are causing this relationship (Wheeler et al. 2004). This is similar for cliff height and total length of the landslides, as there is only about a 26% chance that this relationship occurred by other factors. This is understandable as the cliff height will control the amount of accommodation space available and thus the size of the mass that fails in a landslide (Jenkins et al. 2011). The weakest relationship is between cliff height and horizontal offset as there is a much greater chance that other factors such as the lithology are influencing this relationship (about 33%). The majority of the landsliding in the area is complex in nature, which is probably due to the great variation of lithology over the entire area and the complex physical properties of the materials which is highlighted by the previously discussed red cliff complex landslide. The main movement of this landslide is believed to be rotational as the toe area of the displaced mass shows rotation and that ponded water has developed behind the toe of the landslide, which is typical evidence of a rotated block as the block is usually backward tilted creating a depression for water to pond (Varnes, 1978). However the complexity

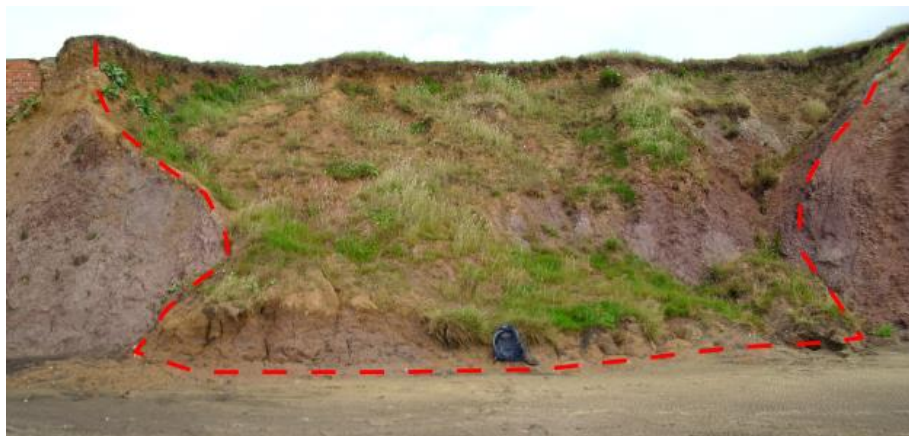
Figure 3.6 Shallow Translational (planar) landslide in Sandown Bay, failure occurring near top of cliff (2). 40L back pack for scale.

The translational (planar) slides in Sandown Bay are different to the ones in Whitecliff Bay (Figure 3.6); the U-shape form is lost, except possibly at the back of this landslide where the failure originated from, they also have a mass of material accumulating at the front of the landslide that has not rotated.

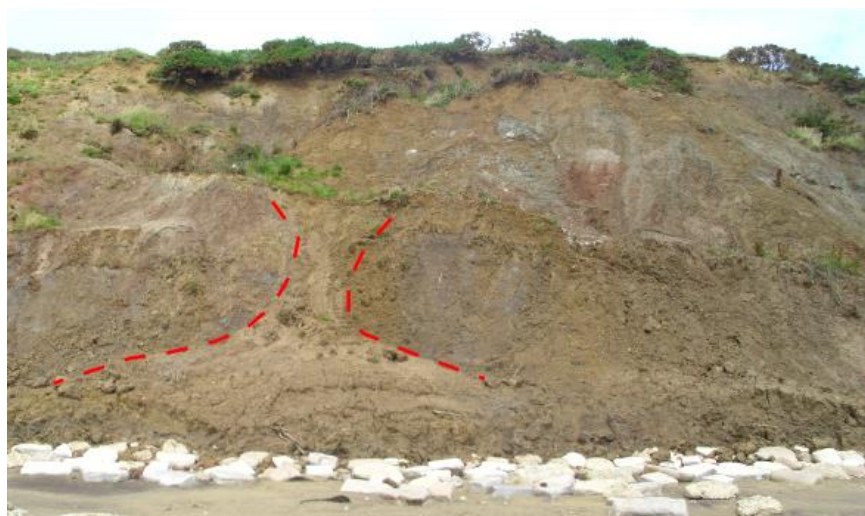
Figure 3.7 Flow type landslide in Yaverland (6).

displaced material accumulating at the front of the landslide, spreading out and forming a lobe (Figure 3.7).

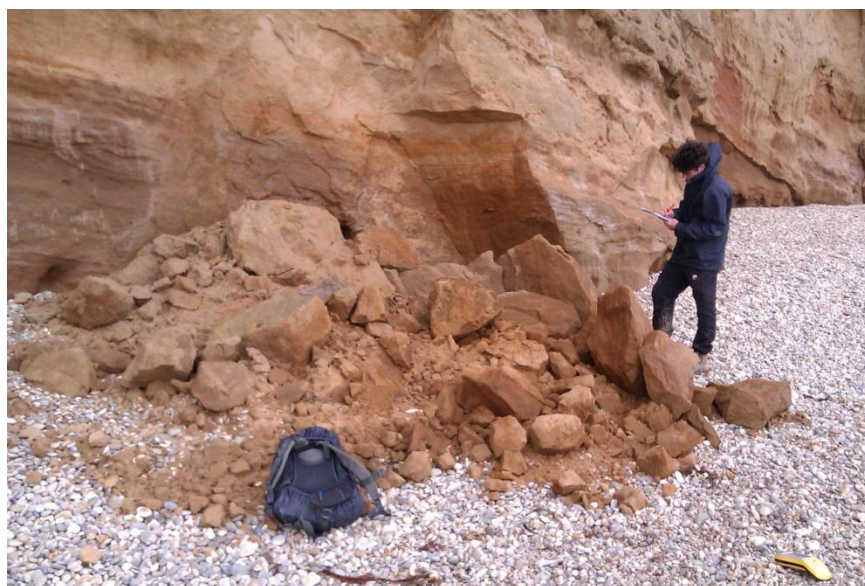
Figure 3.8 Fall type landslide at Red cliff (19). Person for scale and 40L back pack.

The fall type landslides in Sandown Bay are similar to that in Whitecliff Bay showing an accumulation of rocks at the base of the cliff (Figure 3.8 & 24, Figure 3.11).

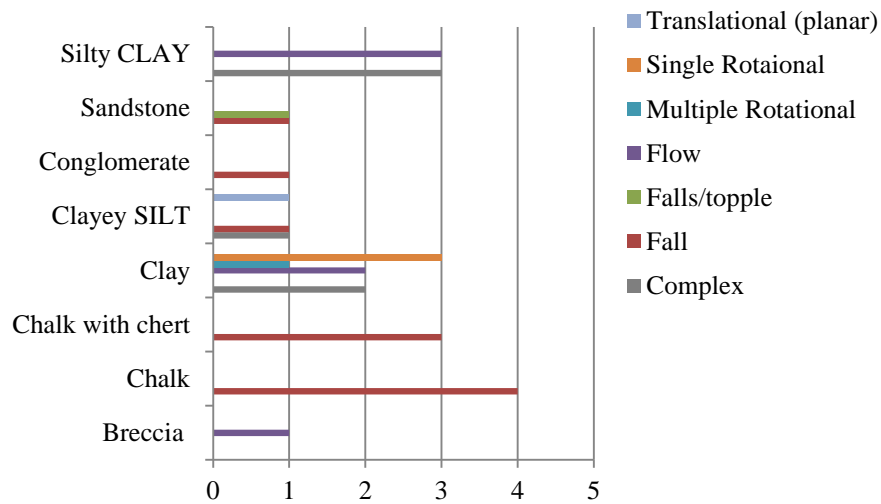
Figure 3.15 The relationship between movement type and lithology for landslides that involved a single lithology.

landslide involved lithified material with Chalk being the most common (Figure 3.15-3.17).

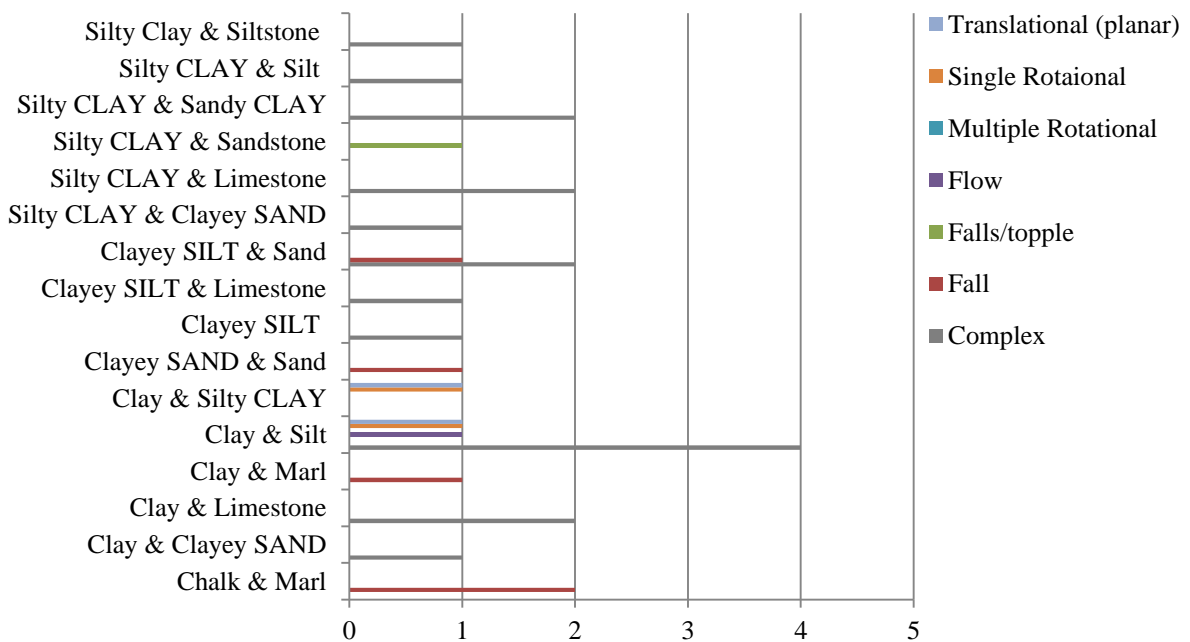
Figure 3.16 The relationship between movement type and lithology for landslides involving two lithologies.

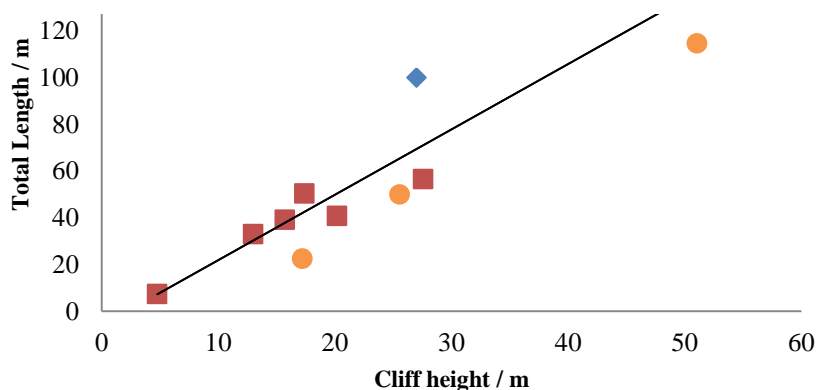
Figure 3.21 The relationship between cliff height and total length of landslides with rotational nature. Red squares: Single rotational, blue diamonds: Multiple rotational, orange circles: Complex (Single rotational), circle with the greatest height is Complex (multiple rotational). Trend line calculated using linear regression.

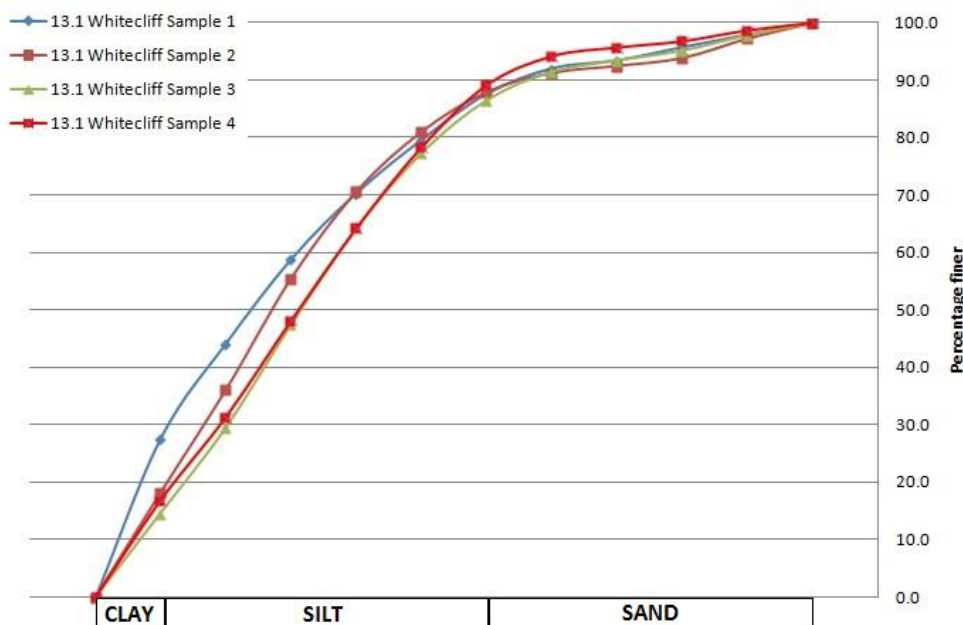
Figure 3.27 Particle size distribution plot (see appendix D for percentage break down) for the samples taken from the mud slide / flow landslide at Whitecliff. Numbers correspond to locations samples were taken (see geomorphological map Figure).

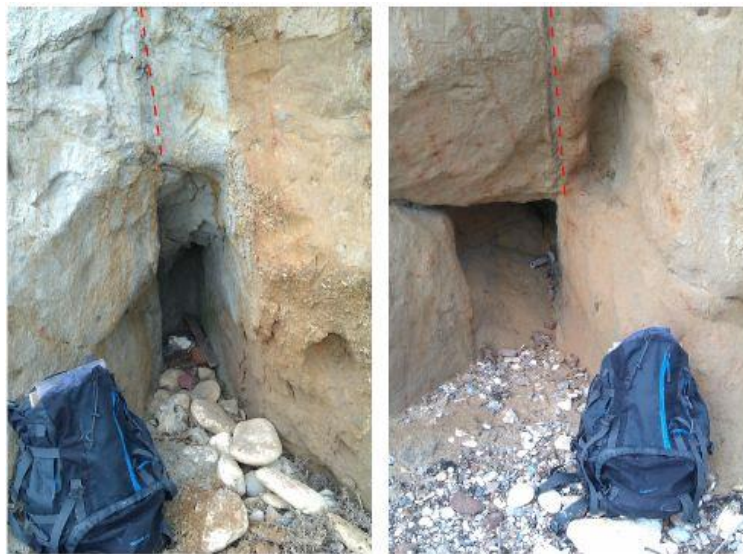
Figure 4.3 Gullies forming where there is a thicker clay horizon, located left of the red dotted line.

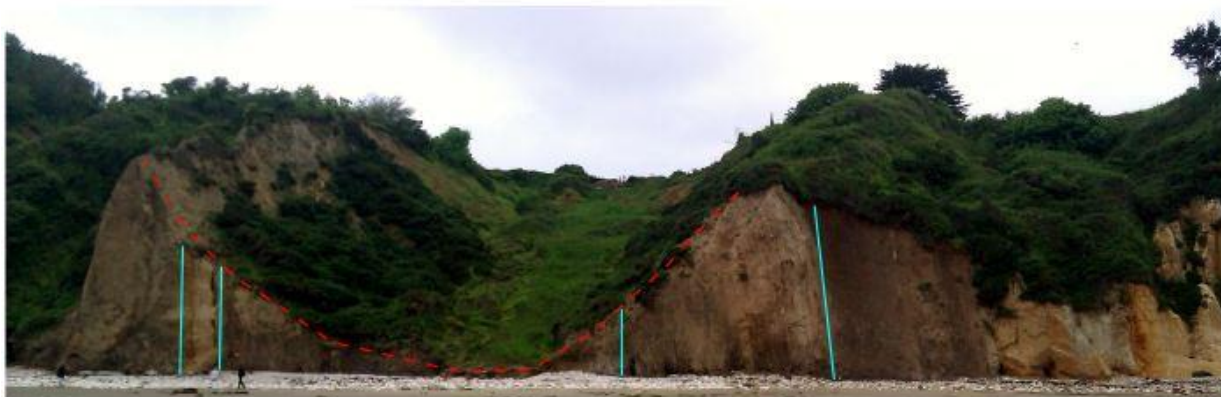
Figure 4.4 Complex landslide (9, Figure 3.12) showing the relationship between bedding surfaces and the extent of the landslide.

1982). However, landslides 11, 14, 15, 16 and 17 (Figure 3.12) are all occurring where bedding surfaces (contacts) occur and thus they could be making the slopes more susceptible to landsliding. Landslide 9 (Figure 3.12 & 4.4) shows that the deepest part of the landslide is in the centre implying that the failure occurred towards the centre of the landslide and thus away from the bedding surfaces, showing that they may have had little influence on this landslide.

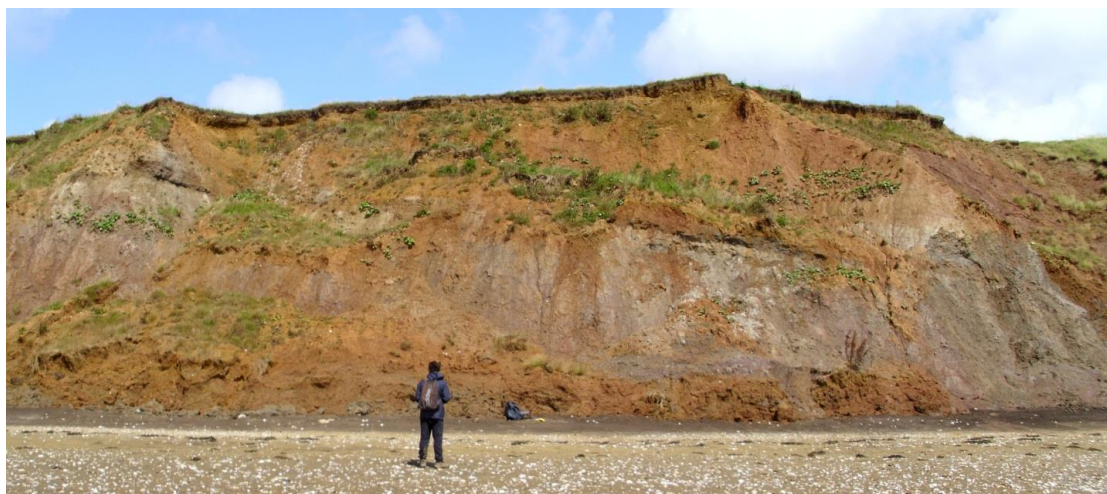
Figure 4.6 Failure occurring in the superficial geology, which is possibly related to increased pore pressures at impermeable layers.

Due to the dominance of low permeable fine soils forming a major component of the lithology in the area (figure 3.11 & 3.12), there is then the potential for shear surfaces to develop where there is a contact between a more permeable layer such as a sand and a more impermeable layer such as a clay. The water meeting the more impermeable layer will cause an increase in pore water pressures and this increase can reach a point when it overcomes the shear strength of the material forming the slope thus producing a shear surface for failure to occur on (Jones and Lee, 1994). However, where the bedding contacts are vertical (Whitecliff, Figure 3.12) it is unlikely that significant pore water pressures will develop as the water will be able to flow parallel to the bedding, under the influence of gravity, as the dip of the bedding favours the ingress of water (Jones and Lee, 1994). This is supported by the fact that slip surfaces along bedding contacts between low and high permeable layers do not appear to be occurring in Whitecliff (Figure 3.12, 24 & 26). However, it could be a possible mechanism for landsliding in parts of Yaverland (Figure 4.6) as the lithology is dipping shallowly not steeply. The failure has mainly occurred in the Silty SAND unit running along the top of the cliff. The unit below this is a more impermeable Silty CLAY and thus during high rainfall, pore water pressures could have built up along this impermeable layer until it caused the unit above to fail.

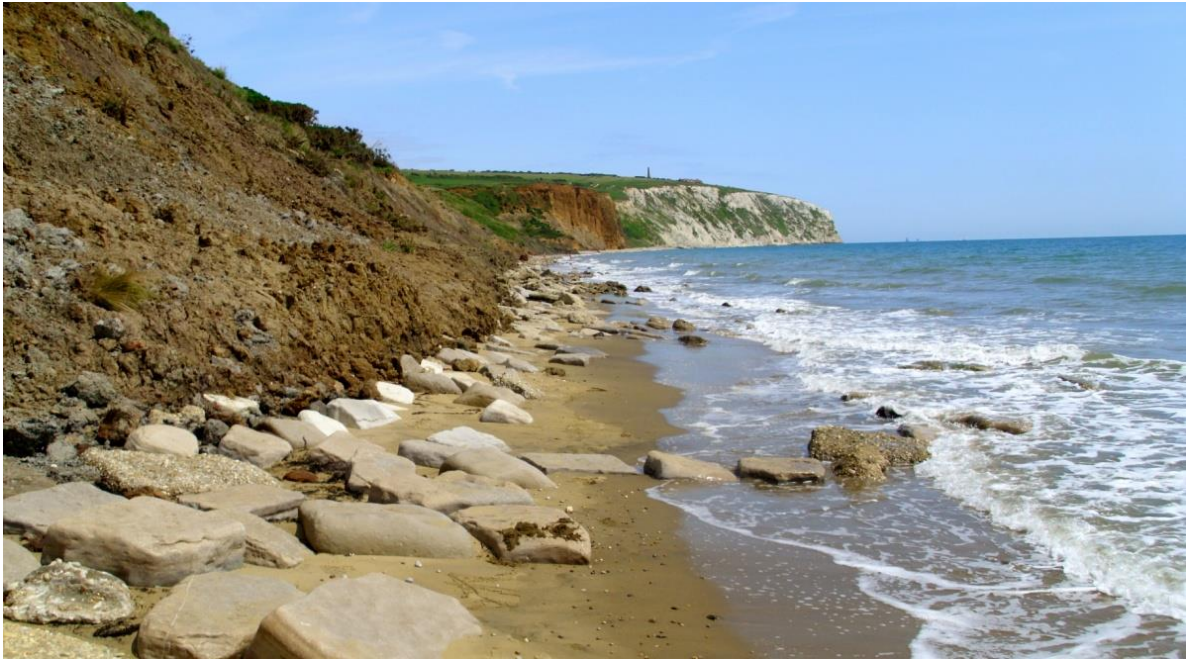
Figure 4.7 Evidence of the sea reaching the base of the cliffs near high tide.

At high tide the sea reaches the base of the cliffs in most of the area (Figure 4.7) except in parts of Yaverland especially from the succession of sands (Ferruginous Sands) up until the chalk. The effect that the sea will have will be to remove material from the toe of a landslide. This then reduces the stability of the slope and can promote further recession through landsliding (Lee et al. 2001). The removal of material from the base of a slope also causes the slope to steepen which is argued by Wolters and Muller (2008) as being the critical factor for increasing slope instability. However, the deposition of material at that base of the slope provides protection from wave run-up and thus erosion only occurs when the debris has been removed (Lee, 2008). This then could also explain why the chalk group has receded the least, as the falls will deposit material at the base of the slope providing a natural protection to marine erosion. This effect will be diminished in soft rock cliffs (majority of the study area) as the displaced material deposited at the base of the cliff / slope will be highly disturbed and in a fully softened state which will mean it can be easily eroded (Castedo et al. 2012). Thus, this will have the effect to provide the condition for continuous landsliding as marine processes will be able to easily remove material from the base of slopes as most of the area consists of soft rock cliffs (Figure 3.11 & 3.12).

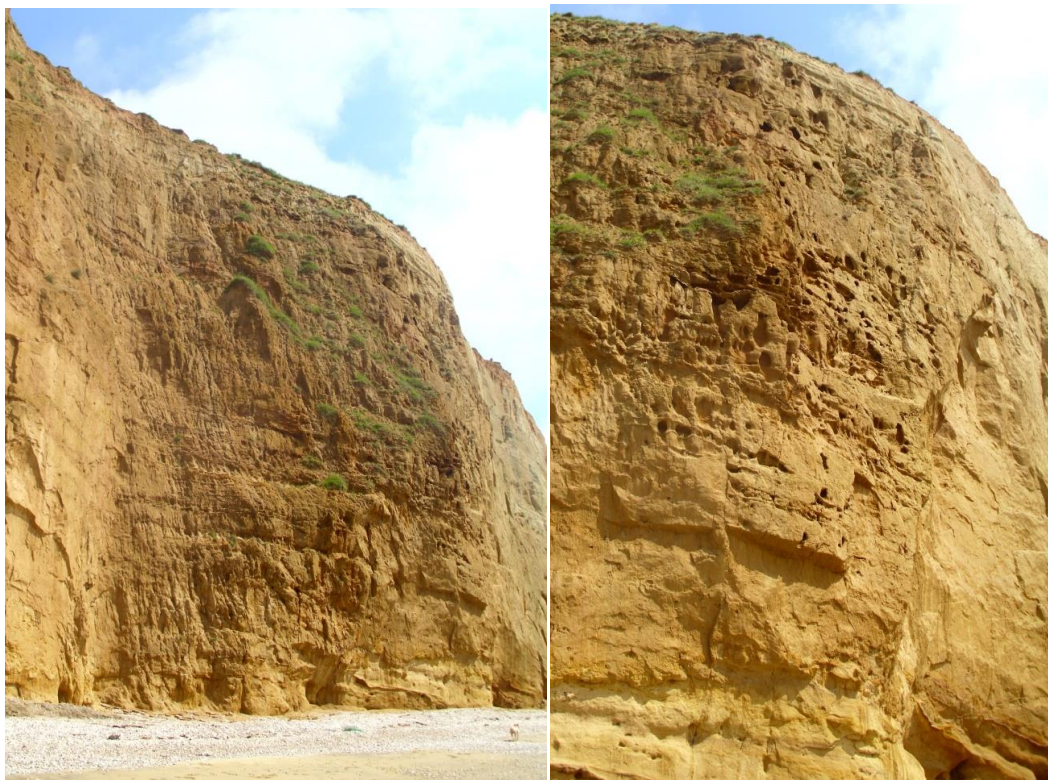
Figure 4.8 Tafoni forming in the sand cliffs of the Ferruginous sands in Sandown Bay.

Even though the sea does not reach the base of the cliff at the Ferruginous Sands (Figure 3.9), there is still evidence of marine processes affecting the sands in the form of tafoni (Figure 4.8). The tafoni is most likely due to salt weathering (Huinink et al. 2004), due to it being a coastal setting, and is an example of cavernous weathering and results in the weakening of the cliff face (Mol and Viles, 2012). Thus, this can lead to the development of material falling from the cliff face and as tafoni structures can grow in size and coalesce to form larger forms (Sunamura and Aoki, 2011), this then could allow material to detach without shearing to produce falls.
