The use of nanosensors for monitoring civil structures

Mousaied Farhoud

Project Advisor: [Dr Sung-Hwan Jang](#), School of Science and Engineering, University of Plymouth, Drake Circus, Plymouth, PL48AA

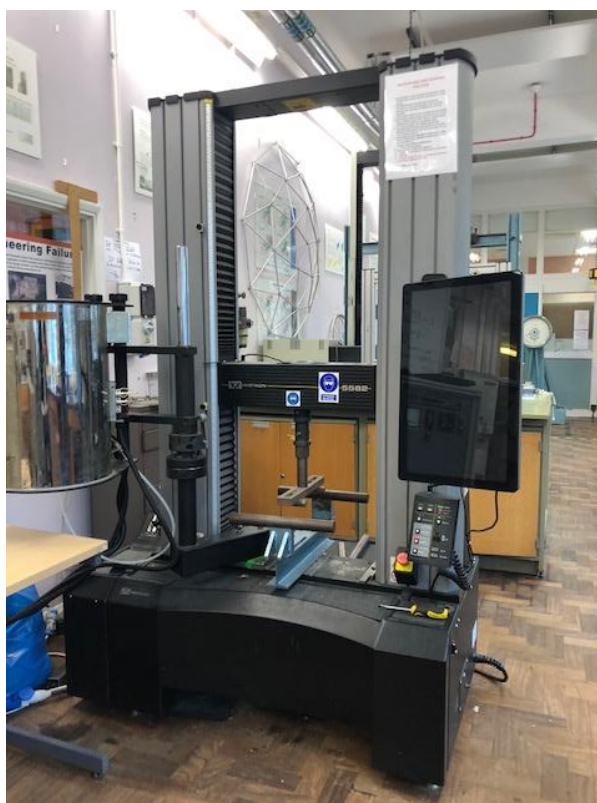
Figure 1: Instron 5582 used for tensile testing CT specimen.

- Instron 5582 shown in Figure 1 was used to test the aluminium compact tension plate in tension.
- Multimeter was used to measure the resistance of the composite which increased with the application of tension
- Instron 3345 shown in Figure 2 was used to test the tube shaped nano-sensors in tension.

The first experiment that was conducted was testing the aluminium plate in tension using Instron 5582 while also recording the resistance made by the coating material. The first step was to test a sample of a pure aluminium plate, which was not hybridised with the coating material.

To examine whether the aluminium plate will obtain what was questioned, a tensile test using the fatigue test machine was used. The specimen was placed between the top and bottom clamps using the control box, which adjusted the distance of the locks to enable the plate to be bolted. Using the control box once more, the distance was increased to disallow any unnecessary movements in the plate from occurring. The device was zeroed and the speed of displacement was decided to be 5mm per minute using the monitor screen on the machine. Once the instrument was set up, the testing began. It was noticed that a crack started to develop once the displacement exceeded 5mm. With the continuation of force being applied on the plate, the crack kept on increasing in size. The crack's pattern was going downwards in a straight line before curving further down the plate. It was also noted that the aluminium plate started to buckle slowly once the tensile force was applied on it. However, it started to increase with the continuous forces applied on it.

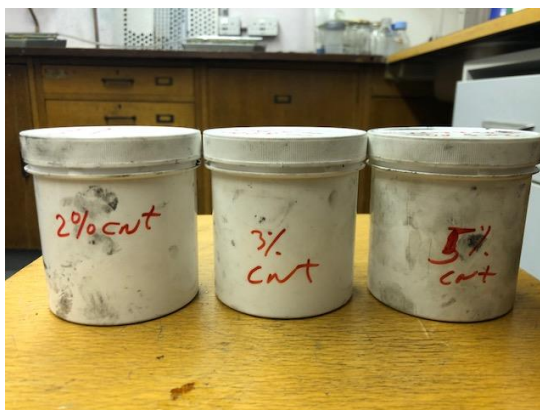
Figure 3: Labelled containers containing the composite.

Carbon nanotubes (CNT) were placed in three small plastic containers with a screw head. Each container was labelled with different percentages of CNT; 2%, 3%, and 5% as shown in Figure 3. To calculate the weight of CNT needed in each container, the weight of Polydimethylsiloxane (PDMS) was required to be determined. It was decided that 20 grams of PDMS will be used. Therefore, the weight of 2% of CNT equalled $20 \text{ grams (PDMS)} \times \frac{2}{100} = 0.4 \text{ g}$ of CNT in the first container. Using the same formula, 3% CNT = 0.6 g, and 5% CNT = 1 g. The CNT was weighed approximately using an accurate scale shown in Figure 4, with a margin of error of $\pm 0.05\text{g}$. 40 grams of Acetone was weighed in on a similar scale, then, added in the mixture to act as a solvent through the next stage.

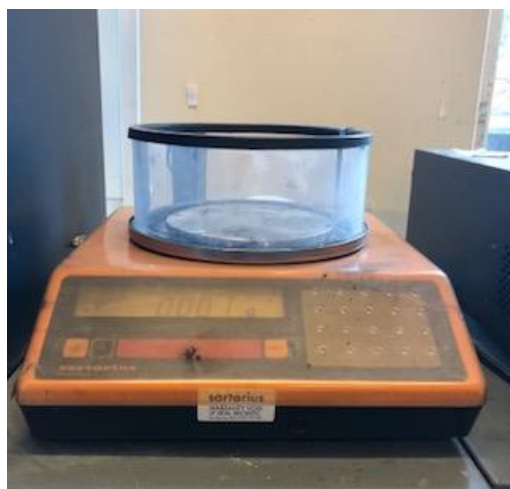
Figure 4: Sartorius scale for sample weight measuring.

- Sartorius scale used to measure the composites weight.
- An engineering bench vise that holds the aluminium plate for the pre-crack process.
- Ultrasonicator, which was used to disperse CNT and PDMS in the acetone.
- Water jet cutting machine to cut the aluminium plate to specifications.

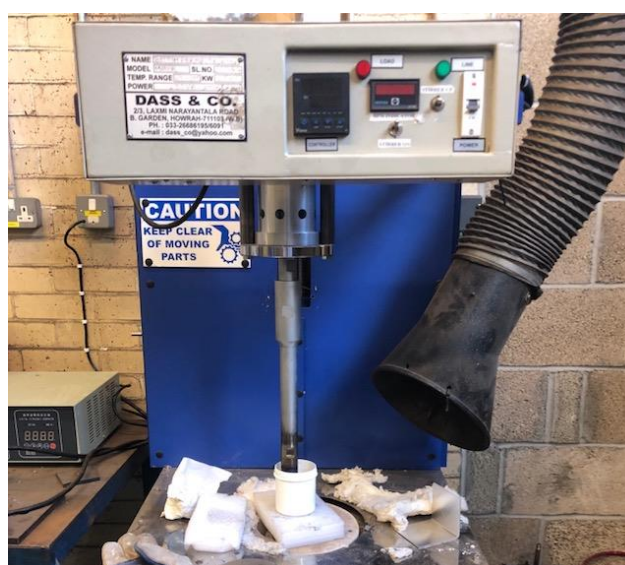
Figure 5: Ultrasonicator dispersing CNT/PDMS.

Due to the material's inability to disperse by regular mixing, a special machine was needed. The ultrasonicator was then used to disperse the CNT and PDMS. Additionally, Acetone was used to aid in the dispersion process. As shown in Figure 5, the ultrasonicator is a device, which uses ultrasonic sound waves to disperse nanoparticles in a solvent. The dispersion process was divided in to two rounds for all three containers. Each container took approximately 2 minutes a round while moving in circular motion to fully disperse the CNT in the solvent. Twenty extra grams of Acetone was then added to the material to get an improved mixture. The 20 grams of PDMS was then added to all three containers. The ultrasonicator was then used to disperse the composites in all containers once more. However, the ultrasonication process took about 5 minutes for each container to dissolve well in the second attempt. All three containers were then placed in an oven with a temperature of 60 degrees Celsius for 3 days to evaporate the acetone from the mixture. The mixtures were then ready to use after being checked if the Acetone fully evaporated out of the containers.

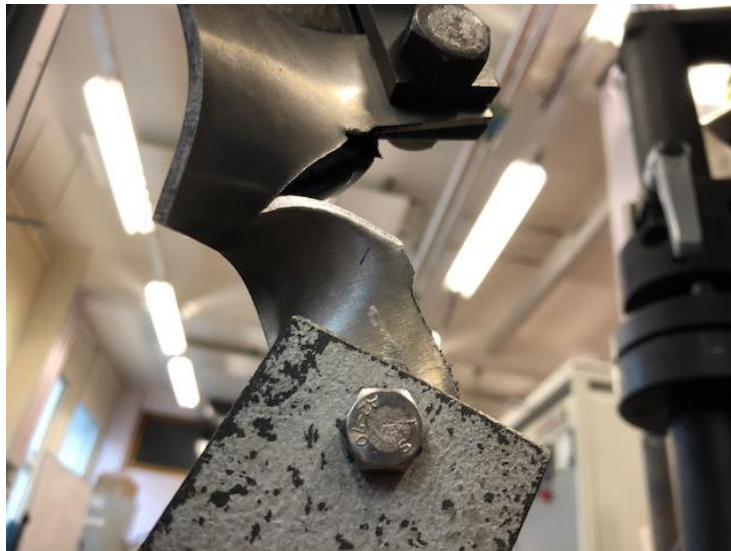
Figure 14: Crack behaviour on the aluminium sample.

To test whether a more brittle material would improve the result, a quick test was conducted on a titanium compact tension specimen. Using the same equipment, tension was applied. Results demonstrated that a more brittle material showed improvement in the materials bending and crack path. A significant reduction in the specimens bending was observed. Additionally the crack had a straighter path with no great curve occurring.

One important observation noticed while in testing was that all samples started to deflect and bend with the increase of tension applied on them. Another observation was that the growing crack did not have a straight path through the specimen. The crack behaved in a curve shape as shown in Figure 14. The reason for the specimen to fail and bend was due to its material being ductile. Another reason which could be a possibility was the dimensions of the specimen. The compact tension specimen was cut to specifications according to a previous sample made in the lab. However, there are standard specimen dimensions which are given from organisations such as ISO and ASTM. Difference in dimensions could affect how the CT specimen acts when in tension.
