Wolf Rock Lighthouse Long-Term Monitoring

James Brownjohn [1,*], Alison Raby [2], James Bassitt [1], Alessandro Antonini [3], Zuo Zhu [1] and Peter Dobson [4]

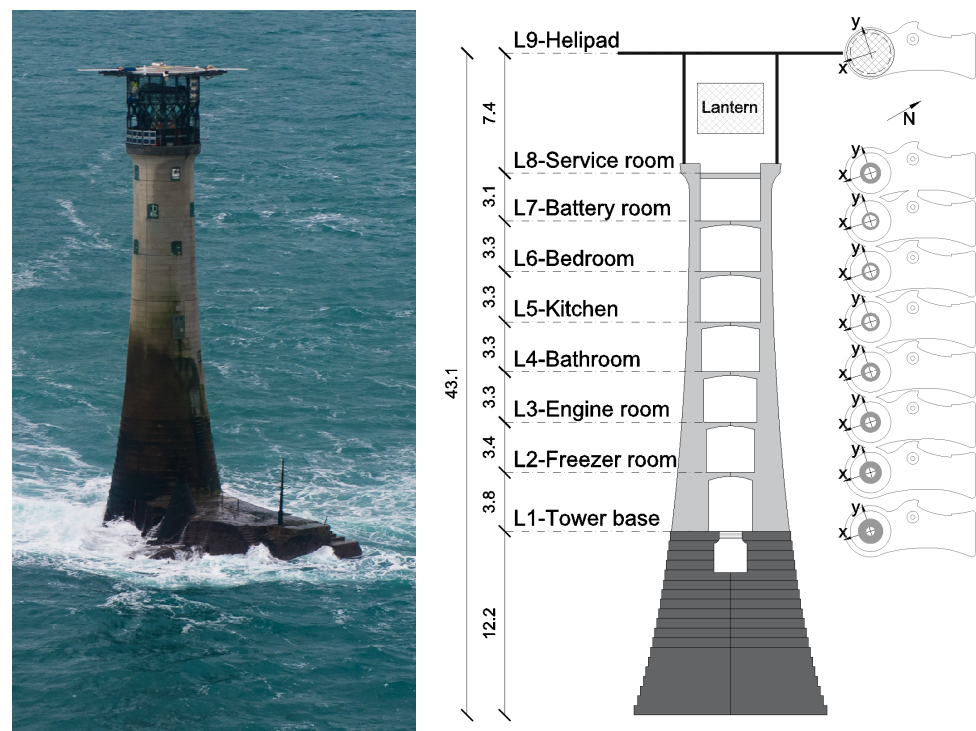
Figure 1. Wolf Rock (photo James Bassitt) and internal layout (heights in m).

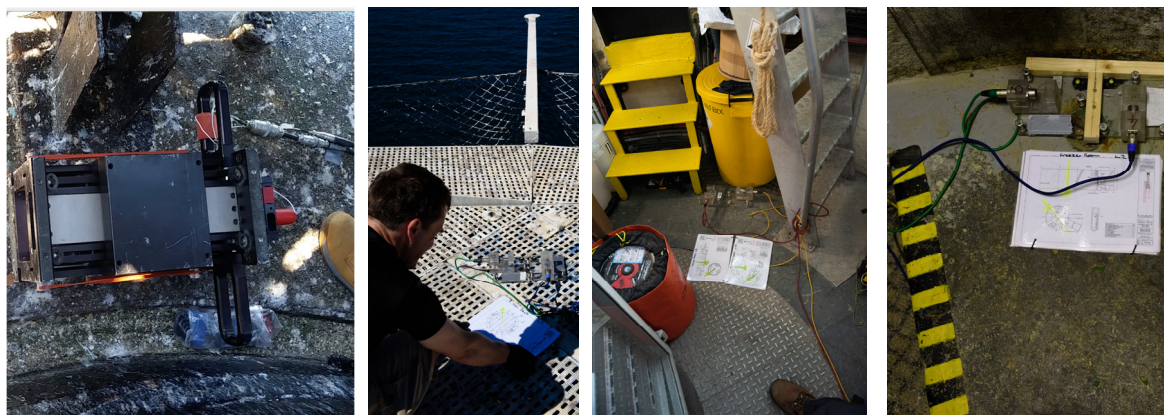
The lighthouse has a sequence of spiral staircases between levels along which signal cables needed to be laid. Avoiding disorientation and preserving alignment between accelerometer pairs at different levels was an unusual requirement for a modal test, requiring reference to floor plans marking salient features such as windows and bulkheads. Figure 2 shows the shaker in position at service room level (lantern gallery), biaxial accelerometer pair on the helideck (level 9), and biaxial pair with alignment jig in the freezer room (level 2).

Figure 2. Modal test. Left to right shaker, accelerometers on helideck, in service room (with steps on right that lead up to lantern level), and (with alignment jig) in freezer room.

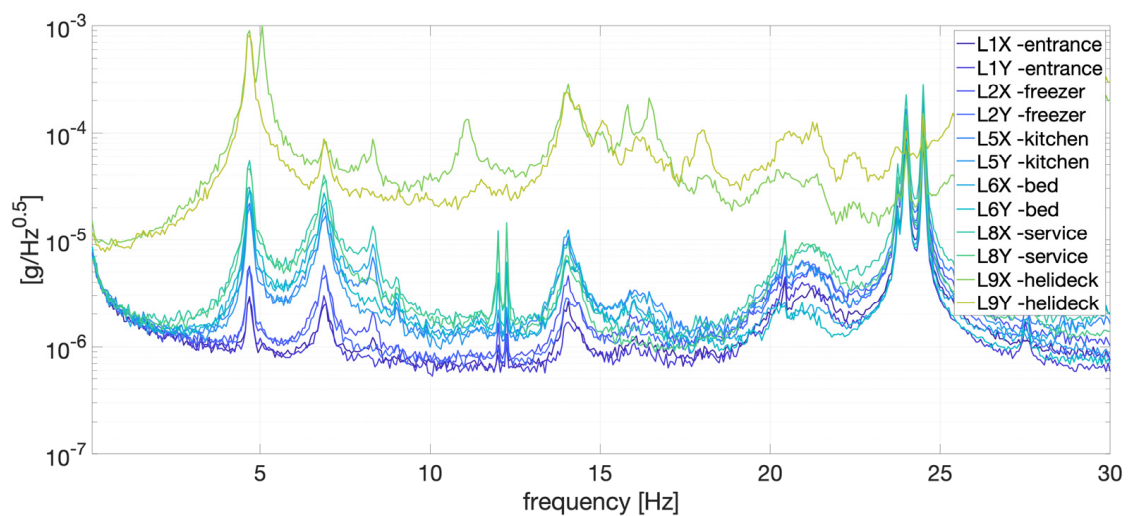
Figure 3 shows ambient response spectra from run2, showing several notable features. The strongest two signals (by an order of magnitude) are for the helideck. Other signals are from the masonry tower for which there appear to be three peaks in the range 0–10 Hz, one around 14 Hz and one around 21 Hz. As well as peaks at frequencies found in the masonry tower, there are other peaks occurring in the helideck at 5.1 Hz and 11 Hz. There are also sharp spikes around 12 Hz and 24 Hz which are most likely not true vibration modes but due to operation of the generator which does not operate at a single constant speed (an extra peak is seen in run5). Peaks believed to represent vibration modes were investigated via operational modal analysis and (including the shaker signal) experimental modal analysis in the frequency domain.

Figure 3. Wolf Rock ambient response, run2.

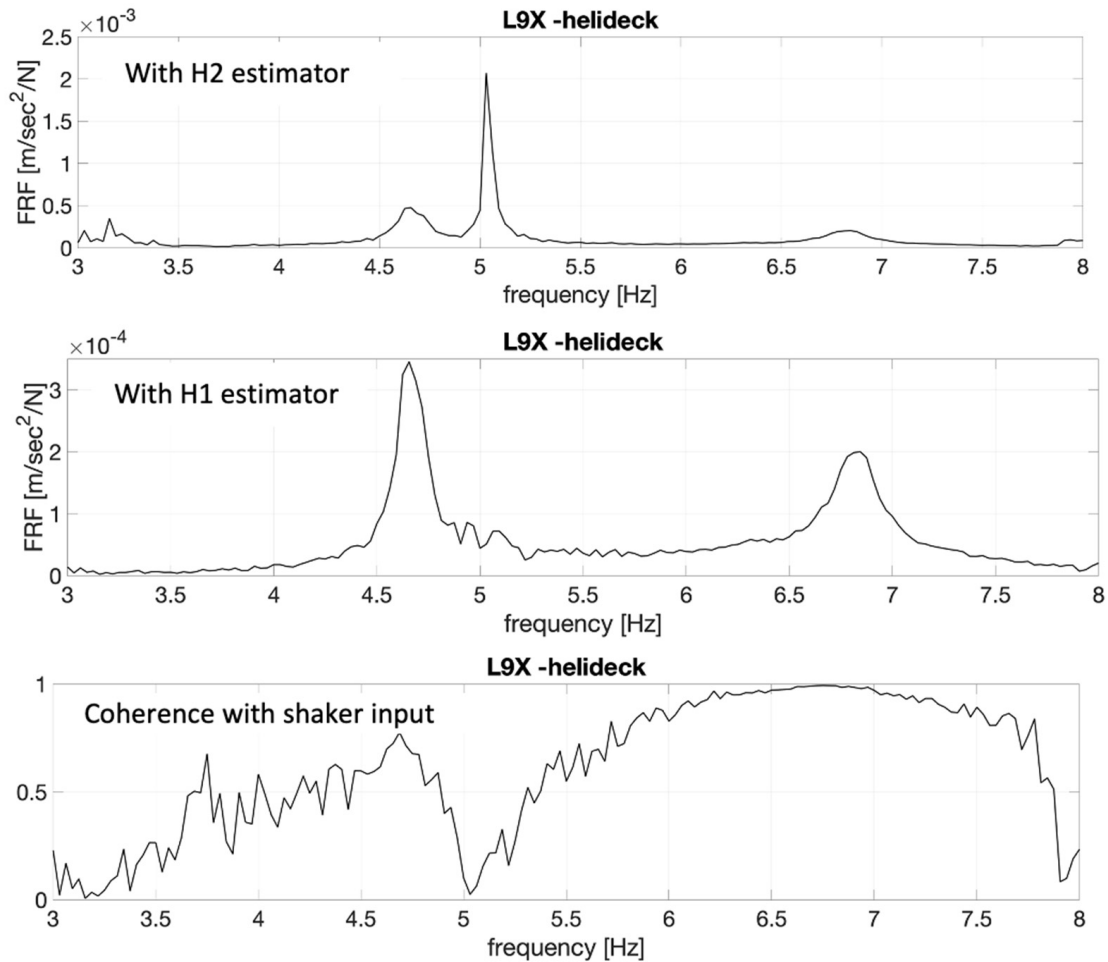
Frequency response functions obtained using the shaker are examined in Figure 4 using both types of frequency response function (FRF) estimator, i.e., 'H1' and 'H2' [21], which are, respectively, appropriate when 'noise' appears/does not appear on the response signal. The coherence function in the lower plot shows the 5.1 Hz signal appearing closer to 5 Hz uncorrelated with the shaker (input), and the peak disappears when using the H1 FRF estimator; hence, it is purely a helideck mode with zero involvement of the tower.

Figure 4. FRFs between helideck (L9) and shaker in x-direction (run18) using H2 FRF estimator (**upper**), H1 estimator (**middle**), and coherence function (**lower**).

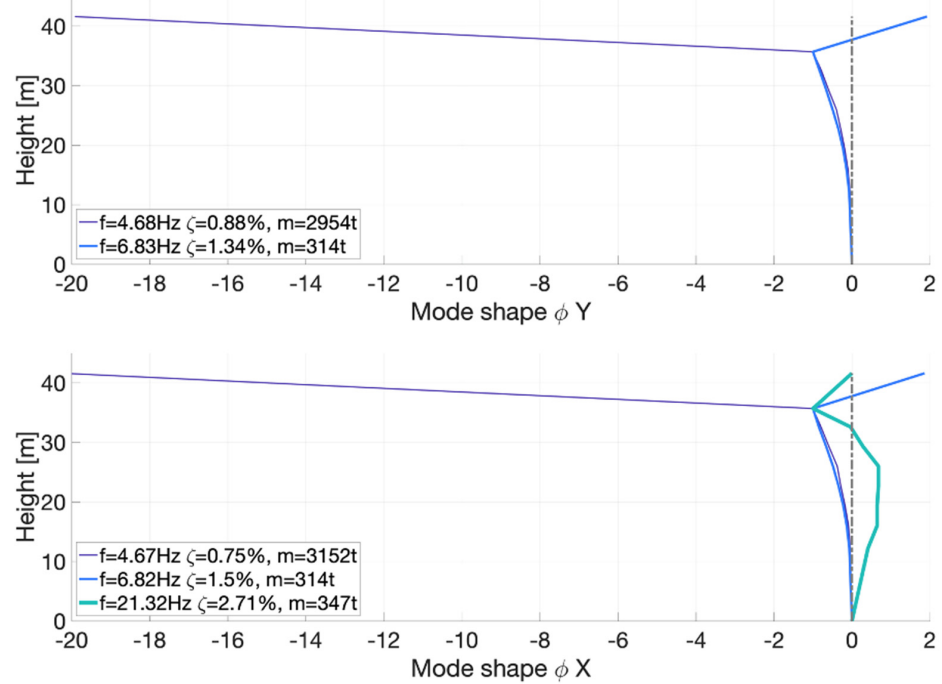
The best estimates for modal parameters obtained using the global rational fractional polynomial method [22] on the FRFs are given in Figure 5. For practical purposes, only the first two modes in each direction are relevant, having almost identical mode shapes, masses, and damping ratios and frequencies for the two directions, so that direction of loading will have a negligible effect on the response. The helideck responds much more strongly in the lowest freuqency pair of modes, which have much larger modal mass for unity scaling at the top of the tower and which will be less strongly excited by horizontal (wave) loads on the tower.

Figure 5. Key modal properties from forced vibration test.

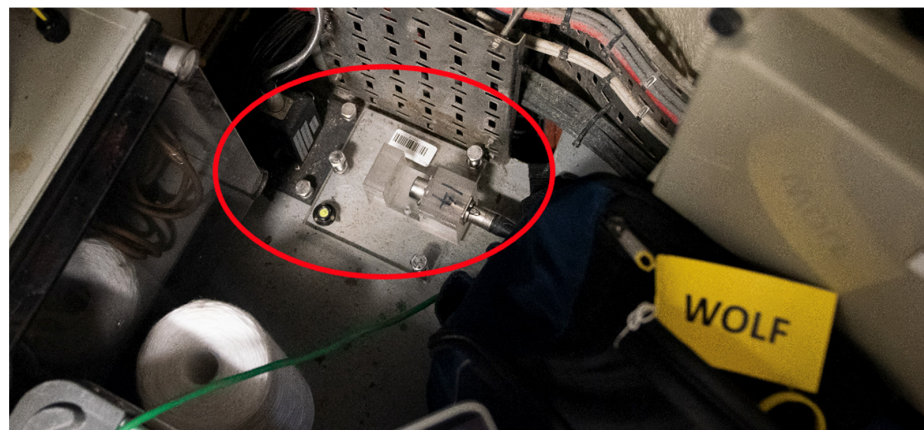
Figure 6. y-direction uniaxial accelerometer in corner of battery room (level 7) adjacent to triaxial monitoring accelerometer.

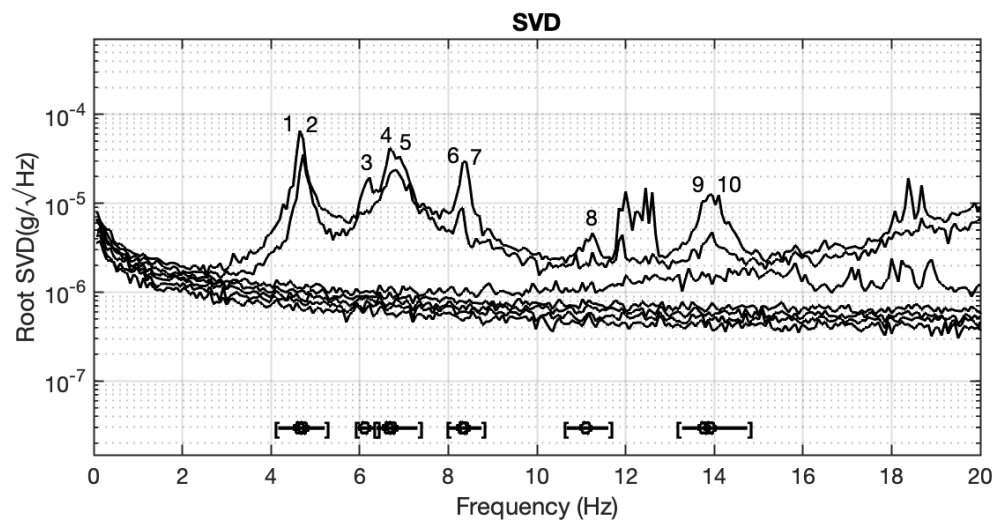
The Bayesian operational modal analysis (BAYOMA) procedure [23] was applied to acceleration signals recorded for eight hours starting 23:11 on 18 January 2019 from four biaxial accelerometer pairs, at levels 1, 5, 7, and 8. The recording was broken into 96 5 min segments from each of which mode shapes, frequencies, and damping ratios were estimated. Singular value decomposition (SVD) of cross-power spectral densities from a sample is shown in Figure 7 indicating four mode pairs. Mode 3 at ~6.16 Hz was not distinct in the overnight recording and was not tracked.

Figure 7. Singular value decomposition of acceleration cross-power spectral density.

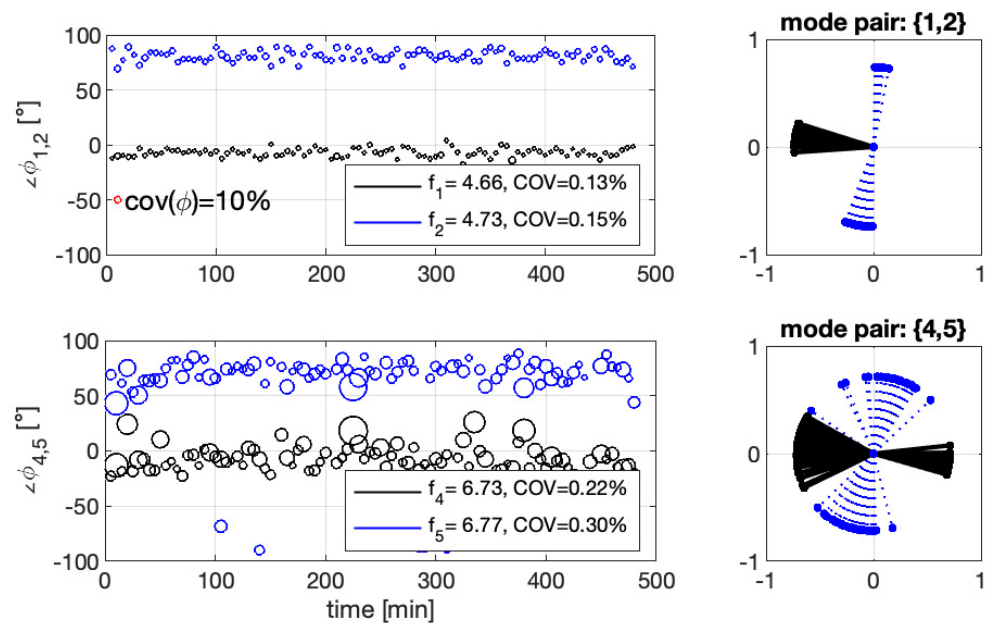
Variation of natural frequencies for mode pairs 1/2 and 4/5 over the eight hours is shown in Figure 8. Mode pair 1/2 frequencies are well separated compared to the forced vibration test values and are identified with high certainty (i.e., with low variance error). Mode pair 4/5 frequencies are close, have higher variance errors and are lower than the forced vibration test values.

Figure 8. Mode shape level 8 ordinates for first two mode pairs from Figure 7.

Mode shapes for these mode pairs are, apart from the missing helideck ordinate, similar to the first two mode pairs in Figure 5, and variation in the level 8 (service room) ordinate over the 8 h is shown in two ways in Figure 8. This indicates that, for the

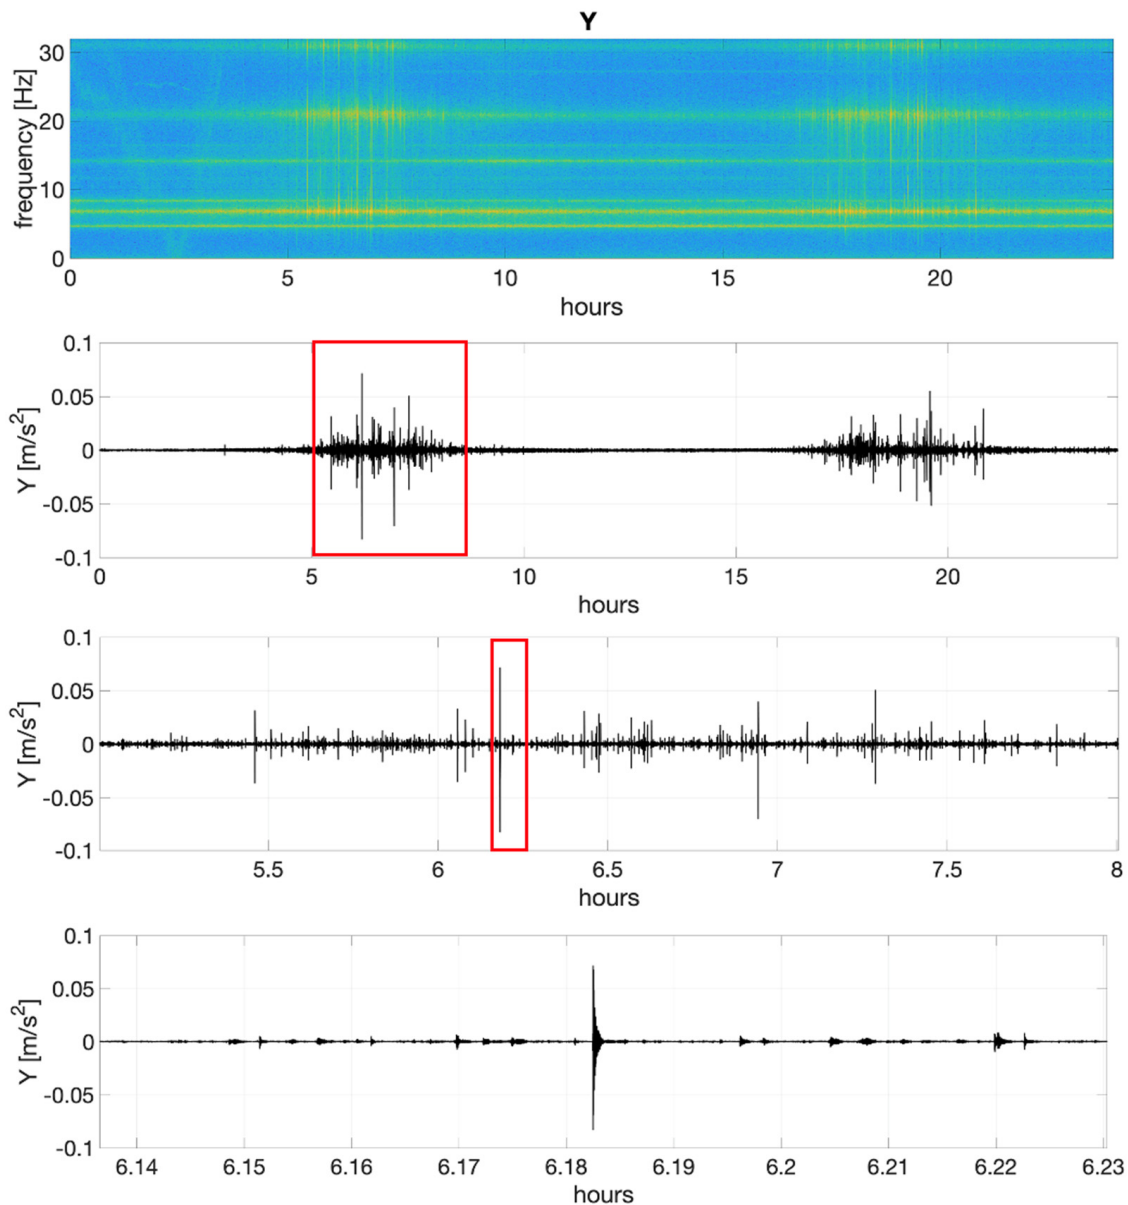
A sample of acceleration data is shown in Figure 10 for one day of relatively strong wave-induced response (23 September 2017), successively zooming in to individual transient responses to breaking waves. The stronger response occurs during the two periods

of high tide (tidal range can reach 5 m), and the spectrogram shows that the mode pair around 6.8 Hz is the most strongly excited.

Figure 10. Sample of wave-induced response during 2017 storm season. Top two rows: time–frequency plot (spectrogram) and time history for complete day, lower two plots successive zoom into single wave impact.

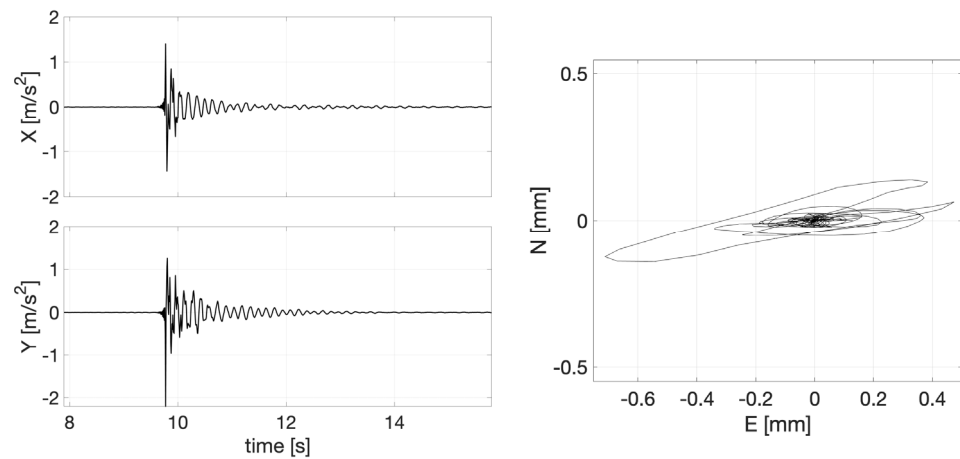
During the monitoring period with available data, several storm events were captured, the majority named by the UK Meteorological Office, others named by the USA (Ophelia), Portugal (Diana, Irene), or France (Matthis). The strongest recorded acceleration was during Storm Brian which reached 2.6 m/s^2, (Figure 11) corresponding to 0.7 mm level 7 displacement aligned south of west, consistent with prevailing wind (hence breaking wave) direction.

Figure 11. Response to wave impact during Storm Brian as acceleration and displacement trajectory.

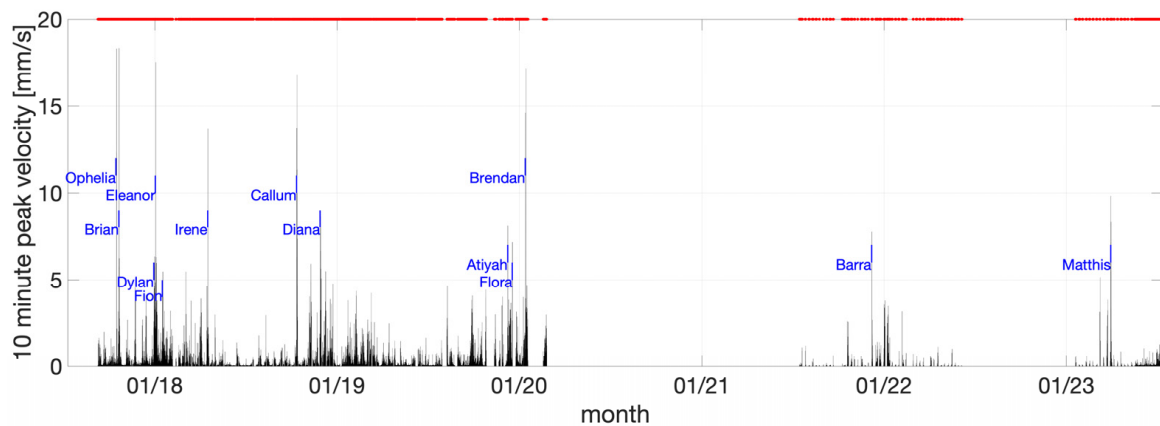
Figure 12 shows peak 10 min velocities over five storm seasons (much of 2020/21 was missed due to COVID-19). Rather than taking accelerations for the strongest wave impacts, peak velocities obtained from the vector sum of integrated level 7 accelerations are shown as they directly indicate wave loads. This is due to the impulsive nature of the response (evident in Figure 10) via the relationship of known modal mass and change of velocity (the indicated peak values) to wave force × duration.

Figure 12. Recorded battery room peak velocities. Red dots indicate available data.

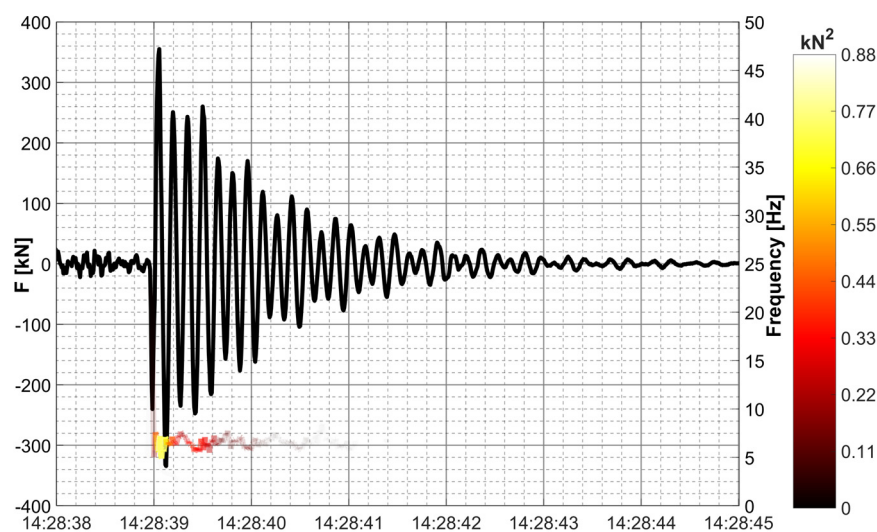
This information has been used to estimate the wave forces experienced due to breaking waves for ex-Hurricane Ophelia. The inertia force of an exemplar extreme wave impact (envisaged via the modal mass for unity mode shape at level 7) is shown in Figure 13. Via the Bayesian inverse identification process described in [25], the response corresponds to a peak force of 7 MN if applied as a breaking wave impact 7.15 m above the tower base and with the strongest part, a double-peak impulsive component lasting 0.06 s. In fact, knowledge of the point of wave impact is not known and is one objective of the video system now in operation.

Figure 13. Inertia force based on acceleration signal and modal mass and instantaneous frequency.

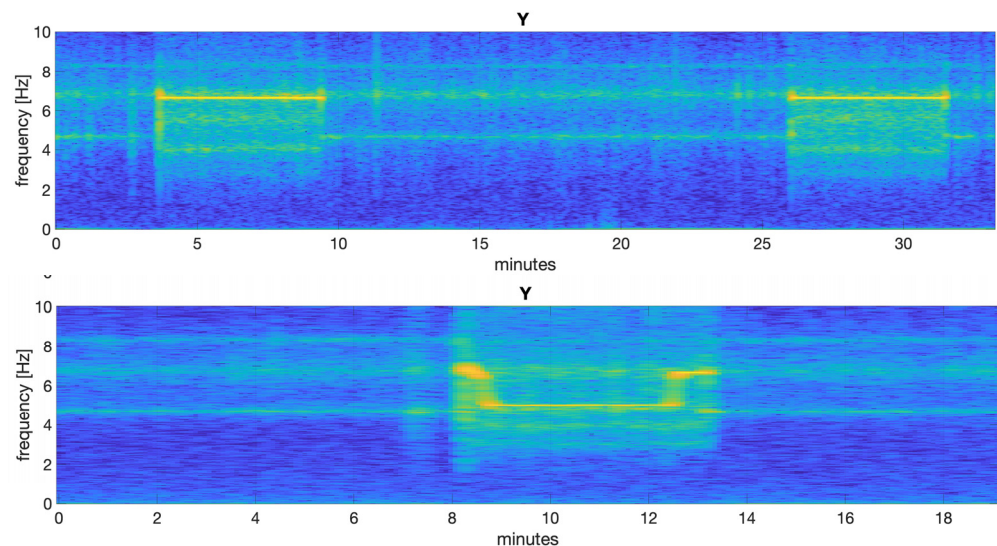
Figure 15. Spectrograms of level 7 response for helicopter visits in 2020 (**upper**) and 2019 (**lower**).

The upper and lower frequencies correspond closely to the 5.01–5.1 Hz mode evident from 2016 ambient response (Figure 3) and the 6.73 Hz and 6.77 Hz estimates obtained from the 2019 ambient response (Figure 8). The forcing function due to the rotors at both full and idling speeds is apparently close enough to mode frequencies to cause resonant amplification.

Even using mode shape ordinates obtained from the forced vibration test to rescale the level 7 vibration amplitudes to estimate helideck accelerations, the levels of vibration would not be at a level and duration that would affect the structure condition.

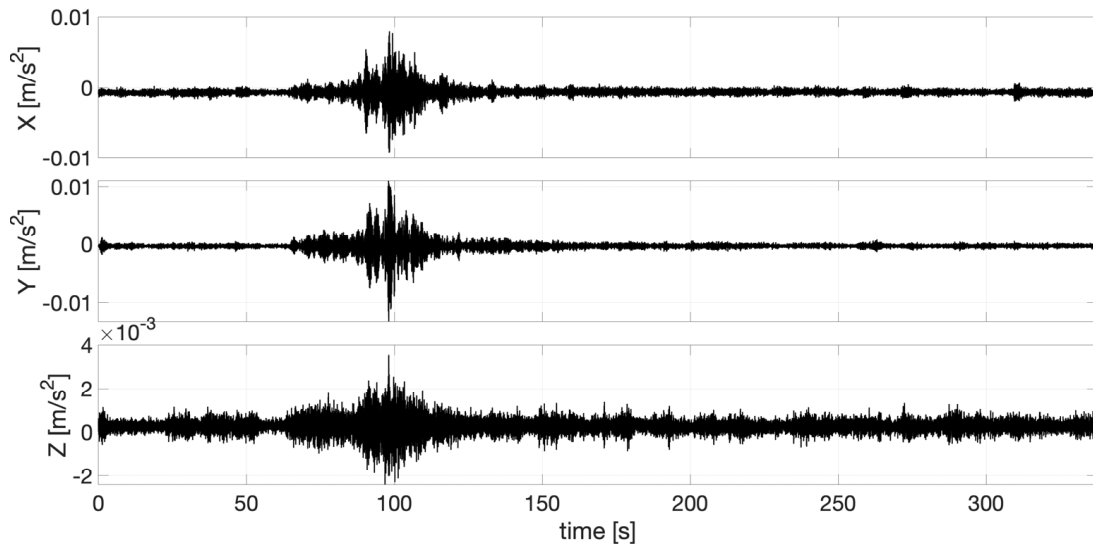
The United Kingdom does not experience strong earthquakes, but there are occasional relatively strong tremors, such as the 4.6 ML Richter local magnitude event of 17 February 2018 [29] around 2:30 P.M. with epicentre at Cwmllynfell, South Wales, approximately 230 km northeast of Wolf Rock. The triaxial response of Wolf Rock Lighthouse, occurring at low tide and with moderate level 7 accelerations due to breaking wave impacts of a rising tide, is shown in Figure 16, with signal duration consistent with the local (Wales) seismometer recordings of the event.

Figure 16. Acceleration time series due to earthquake.

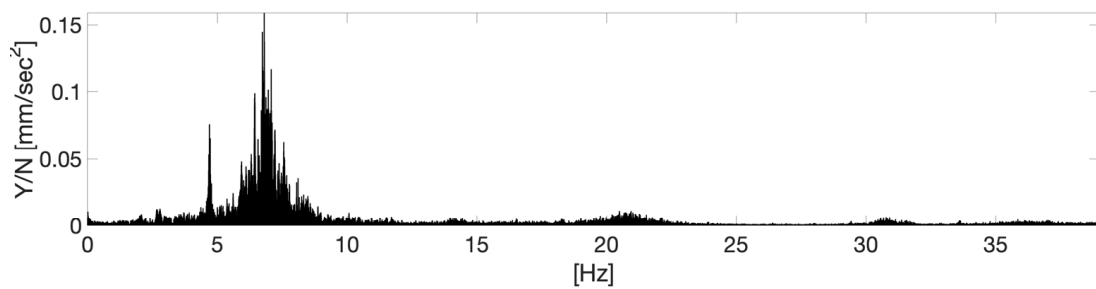
The response is mainly in the second mode (Figure 17; x/east is similar):

Figure 17. Acceleration FFT due to earthquake.

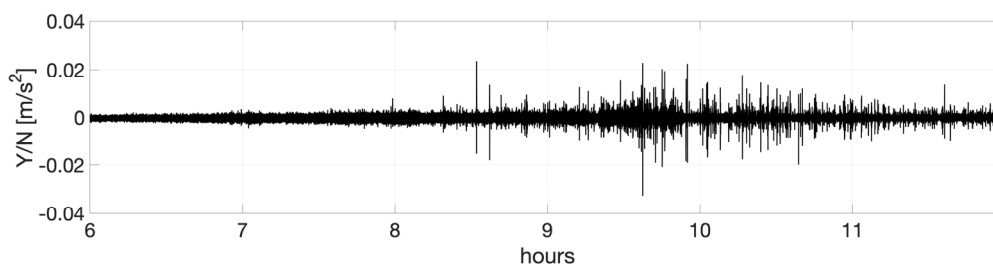
The y/north acceleration for the period from 6 A.M. to noon is shown in Figure 19 and features typical breaking-wave impacts (for a relatively windy summer day) but no evidence of the ship directly impacting the structure.

Figure 19. Acceleration response between 6 A.M. and 12 noon, 10 July 2023.
