Development of a framework for sustainable repair of adobe building in an urban area in Nigeria

**DEVELOPMENT OF A FRAMEWORK FOR SUSTAINABLE REPAIR OF
ADOBE BUILDING IN AN URBAN AREA IN NIGERIA**

School of Architecture, Design and the Environment

April 2012

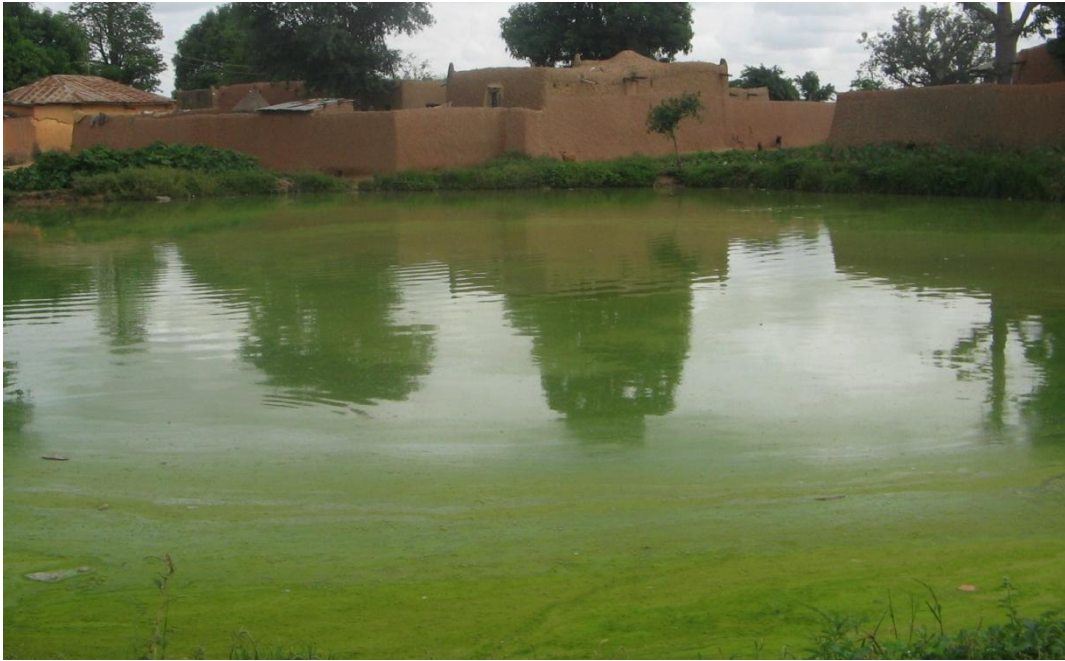
According to the respondents the soil used for earth construction in Zaria City was sourced from burrowed pits within the walled City. However, it was observed that these burrowed pits are filled to the brink with rain water as can be seen in figures 5.5 and 5.6 (see also appendix 2.2.5). According to the interviewees the burrowed pits usually turns to pond every rainy season, thus building earth has to be sourced from the hillsides in the outskirts of the city. The earth is usually transported from the hillsides using donkeys as can be seen in figure 5.7.

Although earth construction and repair are economically viable in terms of availability of material, however, it constitutes both health and environmental hazards to the inhabitants of Zaria City. These flooded burrowed pits usually become breeding ground for mosquitoes during the rainy seasons. This is a serious issue that will require government's intervention because the burrowed pits will continue to get wider as earth is being dug for building purposes. Schwerdtfeger (1982:322) conducted a survey of the city between 1967 and 1978 and noted that burrowed pits takes about 1.9% (347,740 m²) of total area of Zaria City. This total area of the burrowed pits must have increased by 2006 considering the erosion caused by the continuous sourcing of building earth during the dry season and the effect of rain. Some of the buildings in close proximity to these pits are already being threatened by erosion as shown in figure 5.8. More pictures of these burrowed pits are attached in appendix 2.2.5. The possible solution to this menace is to stop the inhabitants from sourcing building earth from these pits and then backfill all. However, this may further encourage the use of other materials most especially cement for repair and even construction of new buildings. Sadly, not everybody can afford cement, thus this may lead to further deterioration of the adobe buildings in Zaria City.

Figure 5.5: A burrow pit turned to pond during the rainy season in Zaria City and all are mosquitoes infested

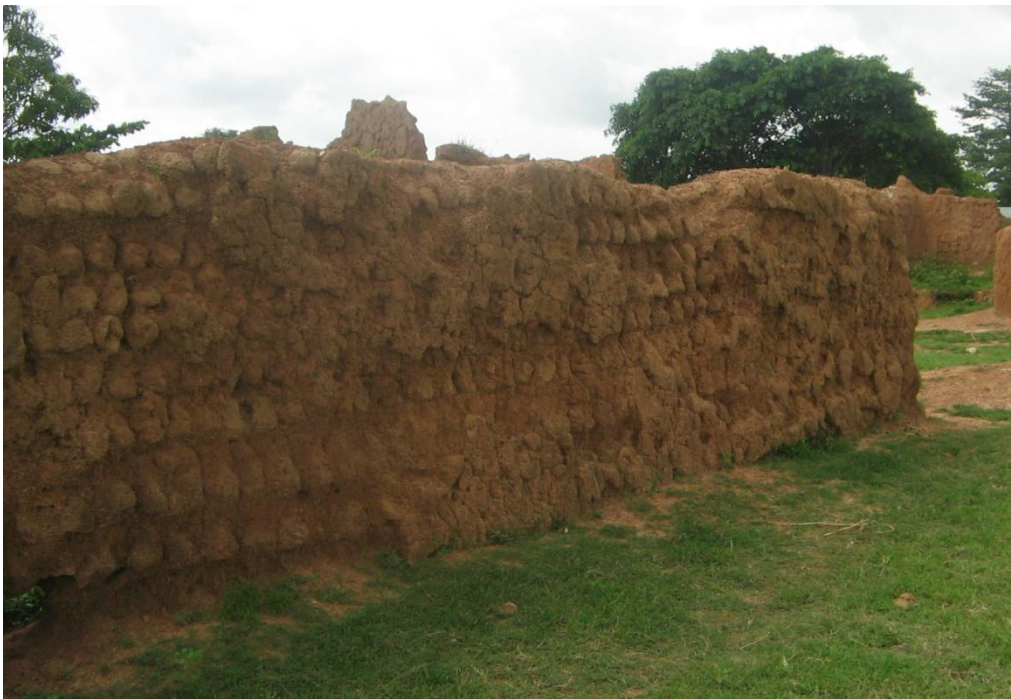
Figure 5.12: A ruined tubali wall in Zaria City

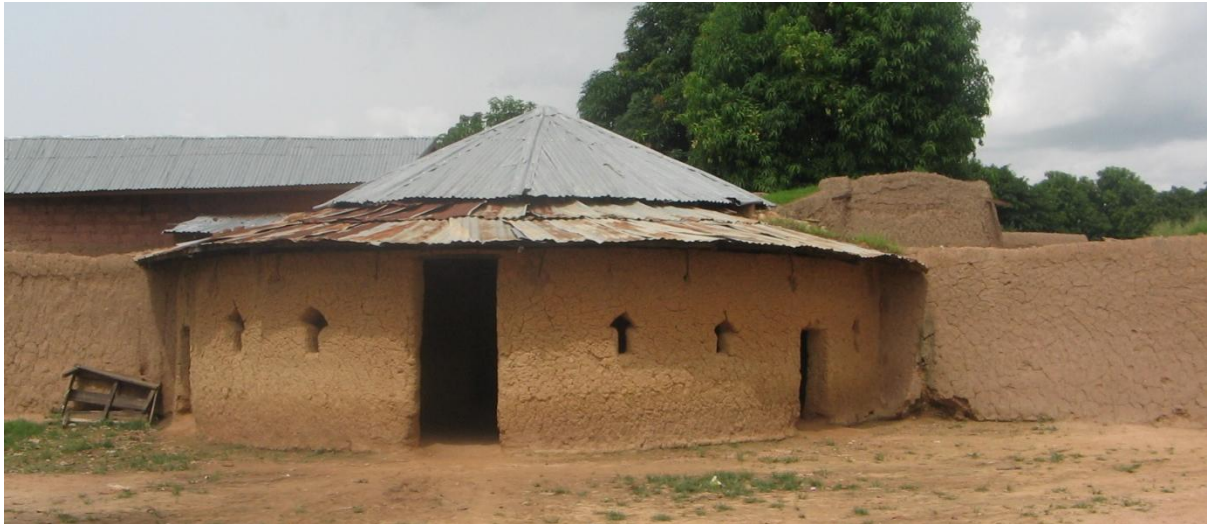
Figure 5.19: Circular plan adobe building with conical roof made from corrugated iron sheets

It was observed that some circular *tubali* buildings have corrugated iron sheets roofs (see figure 5.19). However, the conical shaped roof made of corrugated iron sheets corrodes faster than the roofs of buildings with rectangular plan constructed at the same time, as can be seen in figure 5.19 above. A critical examination of this circular building shows that in order to achieve this conical shape, the rectangular iron sheets were cut and trimmed into various pieces before nailing. These numerous nailed joints are observed to have aided the corrosion of the roof, possibly due to retardation of flow of rainwater at these joints. Leakages were observed from some of these corroded areas.

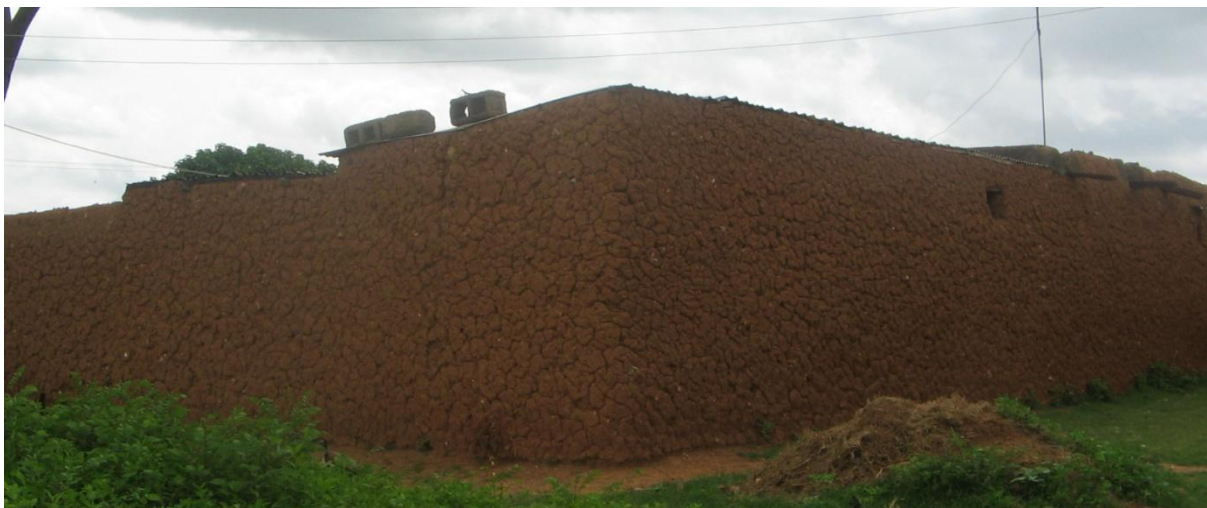
examination of *tubali* building with earth based render shows that the erosion is minimal and even (see figure 5.22). Although the owner of this building cannot remember the exact year that the earth render was last reapplied, however he was confident that it was more than 15 years ago. A further examination of a ruined *tubali* wall (figure 5.9) shows that because of the conical shape of the *tubali*, wider mortar joints are created at the top of the bricks than at the bottom. These irregular vertical mortar joints when filled up ensure that both the earth mortar and later the render are keyed together, thus, creating a strong and structurally stable wall (see figure 5.22; see also Dmochowski, 1990, vol. 1:1.20). Consequently, the earth render are not usually easily eroded and when it does the effect is minimal.

Figure 5.22: A traditional adobe building with earth based render showing minimal and even surface erosion despite the lack of roof overhang

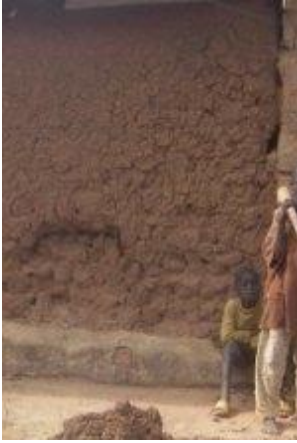
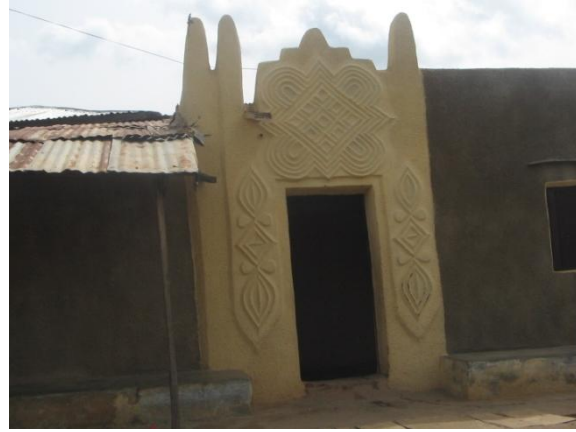
Another implication of thinner walls in the case of the adobe is that erosion could have a fatal consequence if not treated immediately, unlike the traditional types that can still be structurally stable for long period of time. Untreated eroded earth wall can lead to collapse of the wall and this may cause injury or even death. It was observed that the building owners have devised a means of countering this effect by constructing an external plinths with concrete blocks, which is usually between 450 and 600mm above the ground level (see figures 5.23 and 5.24). This concrete plinth called *dakali* in Hausa also serves as sitting area in addition to its primary structural purpose. However, the use of *dakali* as sitting area has another negative effect on the adobe buildings. It was observed that the paints on walls of adobe buildings with *dakali* have flaked and some of the wall render have cracked. The cause of these actions was observed to be as a result of the constant friction by both humans and animals that sit and stand on the *dakali*.

Figures 5.23 and 5.24: Adobe buildings with dakali

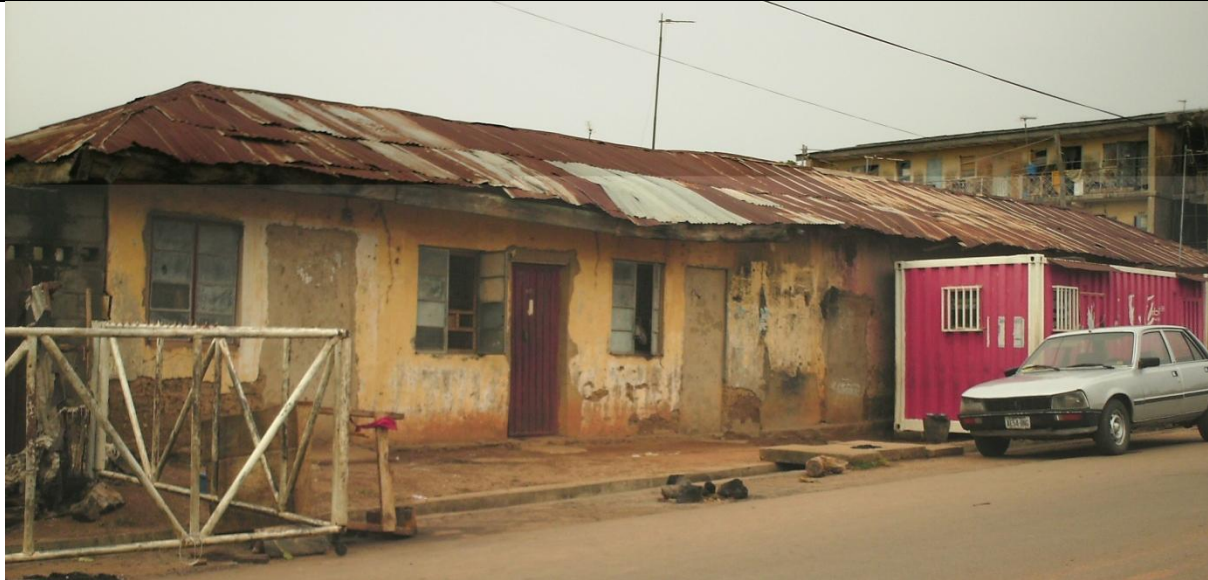
Building No: 01

Defects	Possible causes	Survey method / Evidence
Sagged roof	Ageing and lack of maintenance	Physical inspection and occupants account
Roof leakage	Rusting of roofing sheets and sagging of roof trusses. Due to ageing, lack of repair and maintenance.	Leakages noticed 2 years ago and reported to land lord but roof was never repaired. Sagging was noticed last year that was when some of the roofing sheets were replaced. 1 of the occupants confirmed that the roof was never repaired for more than 20 years that he has been living in the house until last year (2005) when some of the roofing sheets were replaced.
Sagged and rotten roof facial board	Sagging of roof trusses, due to ageing. Excessive moisture from leakages. Possible termite attack due to non treatment of the timber facial board.	Same as above
Cracks on adobe walls	i. Remodelling and use of inappropriate materials. ii. Unsympathetic repair. iii. Lack of ventilation in two of the rooms iv. Introduction of burglary proofs and mosquito's screens v. Lack bonding between old and newly added walls	Physical inspection and occupants accounts. Cracks severe in areas with new electrical wiring. There are no windows in two of the middle rooms.

Dampness on walls	i. Cementious rendering. Use of impermeable oil based paints ii. Underground moisture (capillary action) due to cracking of cementious floor screed	Physical inspection and comparison with other adobe buildings not rendered with cementious material
Basal erosion	Cementious rendering, lack of roof guttering and site drainage as well flooding caused by road rehabilitation.	Observation.
Cracked cementious floor screed	The thick of the cementious screeding on rammed earth floor bed is only 35mm as against the standard 150mm thickness concrete floor slab	The crack is wide and deep in one of the rooms so it is possible to measure the depth of the cementious screed and to see the material used.

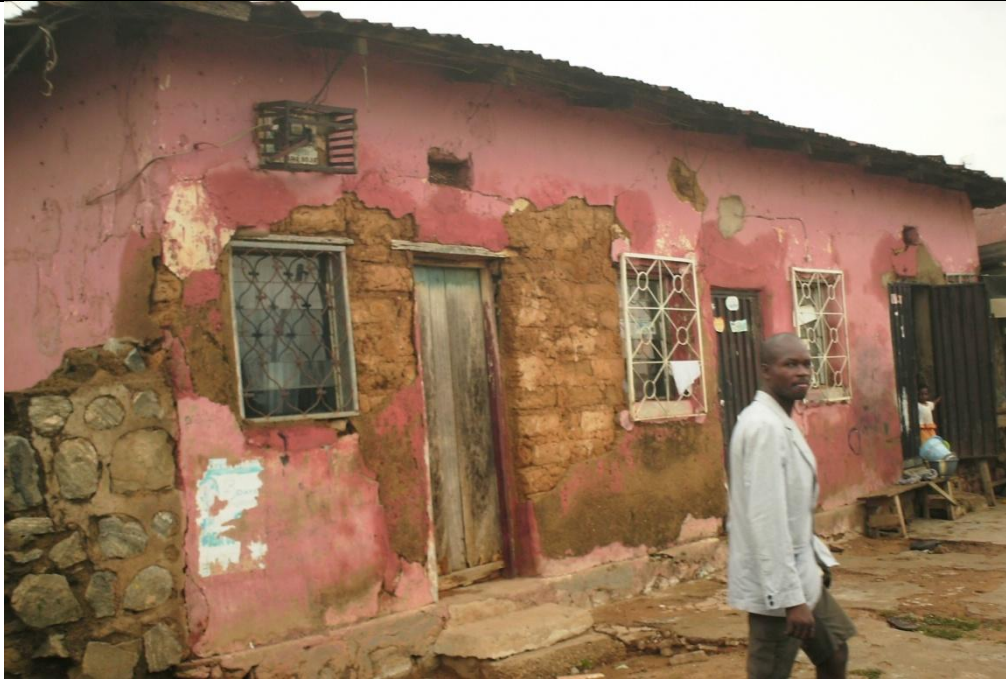
Building No: 02

Defects	Possible causes	Survey method / Evidence
Missing roof facial boards	Ageing and lack of maintenance	Physical inspection and tenants accounts
Crack cementious render	i. Incompatibility of cementious rendering and adobe. ii. Remodelling iii. Introduction of burglar proofs and mosquito nets iv. lack of bonding between rubble stone dwarf fence in cementious mortar and the adobe building	Physical inspection
Cracked adobe walls	i. Incompatibility of cementious rendering and adobe. ii. Remodelling iii. Introduction of burglar proofs and mosquito nets iv. lack of bonding between rubble stone dwarf fence in cementious mortar and the adobe building	Physical inspection
Damp walls	i. Cracked cementious render ii. Oil based paint on the rendered adobe walls iii. Underground moisture (capillary action) due to cracking of cementious floor screed	Physical inspection
Cracked cementious floor screed	The thick of the cementious screeding on rammed earth floor bed is only 25mm as against the standard 150mm thickness concrete floor	The crack is wide and deep in one of the rooms so it possible to measure the depth of the cementious screed and to see the material used.

Basal erosion	Cementious rendering, lack of roof guttering and site drainage.	Physical inspection and tenants accounts

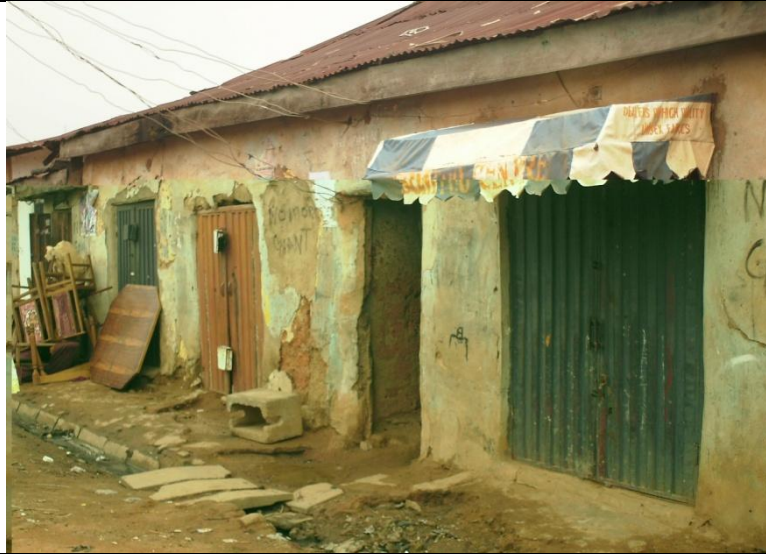
Building No: 03

Defects	Possible causes	Survey method / Evidence
Sagged roof	Ageing and lack of maintenance	Physical inspection and occupants account
Sagged and partially rotten facial	Ageing and lack of maintenance	Physical inspection and occupants account
Roof leakage	Ageing and lack of maintenance	Physical inspection and occupants account
Crack cementious render	i. Incompatibility of cementious rendering and adobe. ii. Introduction of a canopy for signage at the entrance of one of the shops iii. Remodelling iv. Lack bonding between old and newly added walls v. Construction of an addition shop using concrete blocks	Physical inspection
Cracked adobe walls	i. Incompatibility of cementious rendering and adobe. ii. Introduction of a canopy for signage at the entrance of one of the shops iii. Remodelling iv. Construction of an addition shop using concrete blocks v. Failure of timber lintels due to the span of the doors and windows (spans too wide)	Physical inspection and occupants account

Damp walls	i. Cementious rendering ii Entrance canopy iii. Flooding caused by road rehabilitation iv. Underground moisture (capillary action) due to cracking of cementious floor screed	Physical inspection
Crack floor	The thick of the cementious screeding on rammed earth floor bed is only 25mm as against the standard 150mm thickness concrete floor.	The crack is wide and deep in one of the rooms so it possible to measure the depth of the cementious screed and to see the material used.
Basal erosion	Cementious rendering, lack of roof guttering and site drainage as well flooding caused by road rehabilitation.	Physical inspection

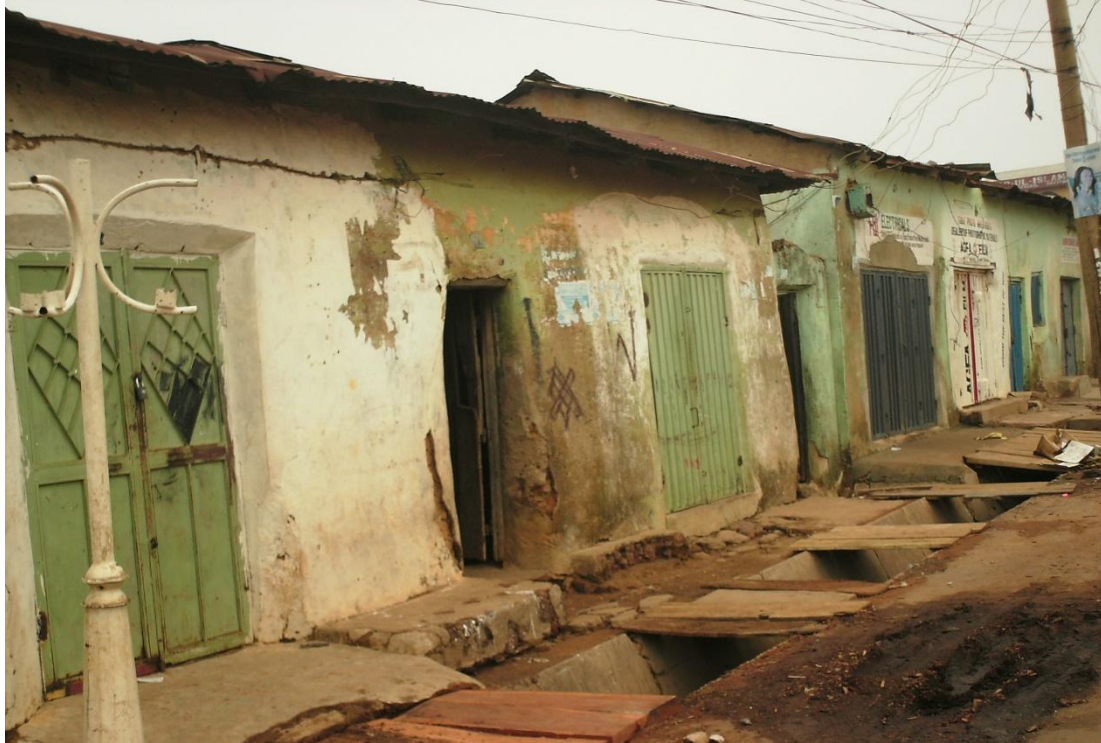
Buildings No: 04, 05 and 06

Defects	Possible causes	Survey method / Evidence
Sagged roof	Ageing and lack of maintenance	Physical inspection and occupants account
Missing facial	Ageing and lack of maintenance	Physical inspection and occupants account
Crack cementious render	i. Incompatibility of cementious rendering and adobe. ii. Use of walls as signage in building number 05 iii. Remodelling iv. Construction of an additional shop using concrete blocks in building number 06	Physical inspection and occupants account
Cracked adobe walls	i. Incompatibility of cementious rendering and adobe. ii. Use of walls as signage in building number 05 iii. Remodelling iv. Construction of an additional shop using concrete blocks in building number 06 v. Lack bonding between old and newly added walls	Physical inspection and occupants account
Damp walls	i. Cementious rendering ii. Oil based paint on the rendered adobe walls iii. Flooding caused by road rehabilitation iv. Underground moisture (capillary action) due to cracking of cementious floor screed v. Use of walls as signage in building number 05	Physical inspection

Crack floor	Insufficient thickness (25mm thick in building number 05, 35mm thick in buildings number 04 and 06)	The crack is wide and deep in one of the rooms so it possible to measure the depth of the cementious screed and to see the material used.
Basal erosion	Cementious rendering, lack of roof guttering and site drainage as well flooding caused by road rehabilitation.	Physical inspection

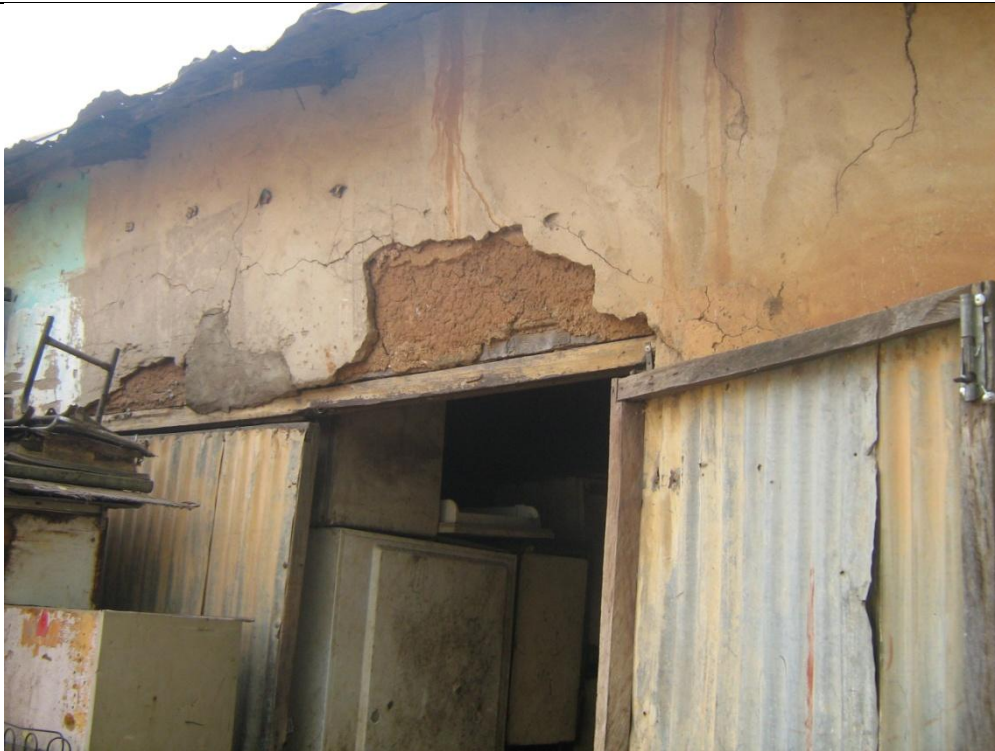
Building No: 07

Defects	Possible causes	Survey method / Evidence
Missing facial	Ageing and lack of maintenance	Physical inspection and occupants account
Crack cementious render	i. Incompatibility of cementious rendering and adobe. ii. Remodelling iv. New electrical installations	Physical Inspection and occupants account
Cracked adobe wall	i. Remodelling using inappropriate material and technique ii. New electrical installations iii. Rain water from the roof of adjoining property iv. Failure of timber lintels due to the span of the doors and windows (spans too wide) v. Lack bonding between old and newly added walls	Physical inspection and occupants account
Sagged timber lintel	i. Remodelling ii. Lintel span too wide to carry the load above	Physical inspection and occupants account
Cracked floor	Use of cementious screed only instead of mass concrete	Physical inspection

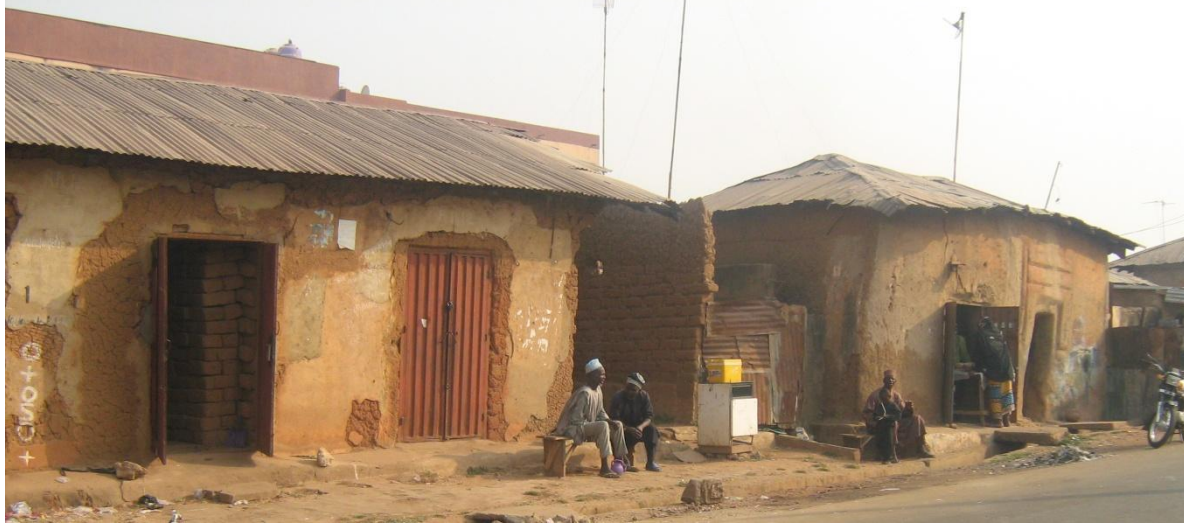
Buildings No: 08 and 09

Defects	Possible causes	Survey method / Evidence
Sagged roof (building no. 09 on the right)	Ageing and lack of maintenance	Physical inspection and occupants account
Leaking roof (building no. 09 on the right)	Ageing and lack of maintenance	Physical inspection and occupants account
Cracked cementious render	i. Incompatibility of cementious rendering and adobe. ii. Remodelling iv. New electrical installations	Physical inspection and occupants account
Cracked adobe wall	i. Remodelling using inappropriate material and technique ii. New electrical installations iii. Lack bonding between old and newly added walls	Physical inspection and occupants account
Damp walls	i. Incompatibility of cementious rendering and adobe. ii. Lack of ventilation no windows in all the front rooms (3 rooms in building number 08 and 2 rooms in building number 09) iii. Underground moisture (capillary action) due to cracking of cementious floor screed	Physical inspection and occupants account

Partial collapse of adobe wall (building no 08 on the left)	i. Negligence and lack of maintenance ii. Consistent remodelling	Physical inspection and occupants account
Cracked floor	Use of cementious screed only instead of mass concrete	Physical inspection
Basal erosion	Cementious rendering, lack of roof guttering and site drainage.	Physical inspection

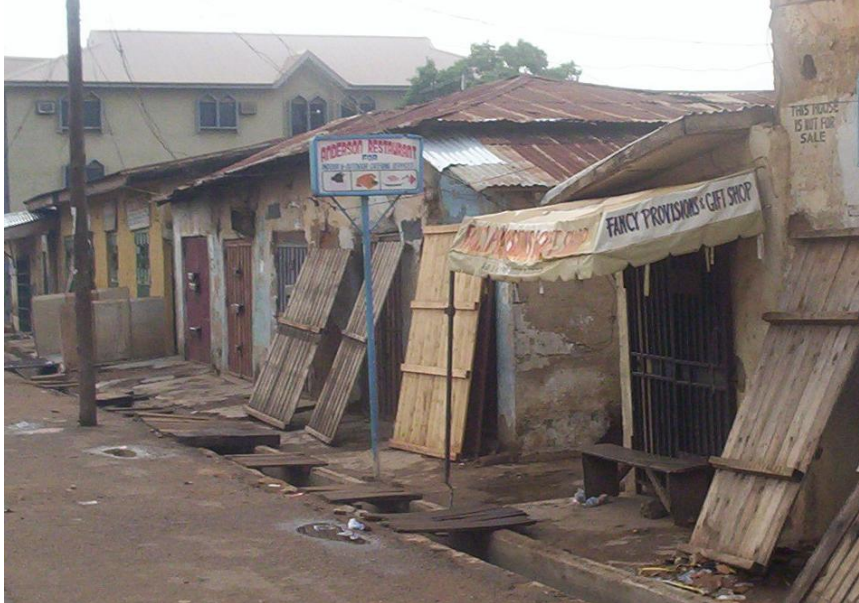
Building No: 10

Defects	Possible causes	Survey method / Evidence
Roof leakage	Ageing	Physical inspection and occupants account
Cracked cementious render	i. Incompatibility of cementious rendering and adobe. ii. Remodelling iv. New electrical installations	Physical inspection and occupants account
Cracked adobe wall	i. Incompatibility of cementious rendering and adobe. ii. Remodelling iii. New electrical installation iv. Failure of timber lintels due to the span of the doors and windows (spans too wide) v. Introduction of burglary proofs and mosquito's screens vi. Lack bonding between old and newly added walls	Physical inspection and occupants account
Damp walls	i. Incompatibility of cementious rendering and adobe. ii. Lack of ventilation no window in 3 rooms used both as shops and bedrooms iii. Underground moisture (capillary action) due to cracking of cementious floor screed	Physical inspection
Cracked floor	Use of cementious screed only instead of mass concrete	Physical inspection

Basal erosion	Cementious rendering, lack of roof guttering and flooding caused by recent road rehabilitation.	Physical inspection

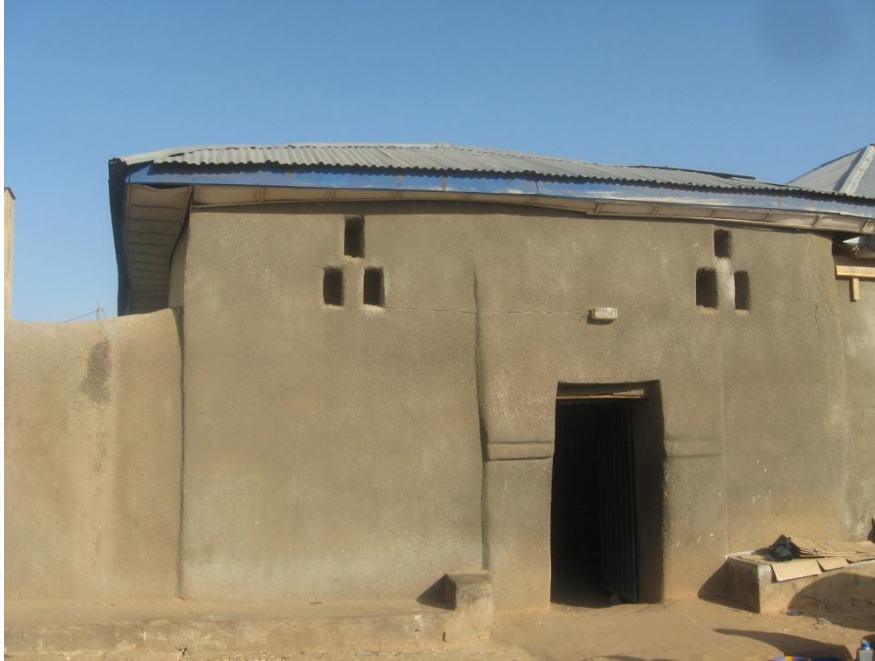
Building No:11

Defects	Possible causes	Survey method / Evidence
Sagged ceiling and facial board	Warping of untreated timber facial board, noggins and joists	Physical inspection and occupants account
Damp walls	<ul style="list-style-type: none"> i. Incompatibility of cementious rendering and adobe. ii. Lack of ventilation no window in 2 rooms iii. Underground moisture (capillary action) due to cracking of cementious floor screed 	Physical inspection and occupants account
Cracked floor	Use of cementious screed only instead of mass concrete	Physical inspection

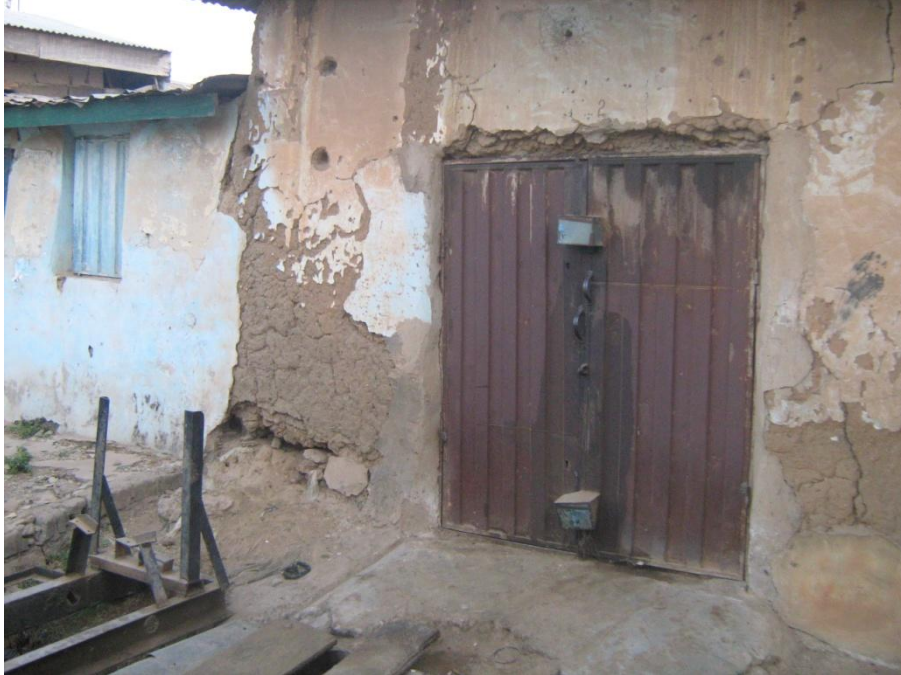
Building No: 12

Defects	Possible causes	Survey method / Evidence
Cracked cementious render	<ul style="list-style-type: none">i. Incompatibility of cementious rendering and adobe.ii. Remodellingiii. Introduction of burglar proofs and mosquito nets	Physical inspection and occupants account
Cracked adobe walls	<ul style="list-style-type: none">i. Incompatibility of cementious rendering and adobe.ii. Remodellingiii. Introduction of burglar proofsiv. Adjoining propertyv. Failure of timber lintels due to the span of the doors and windows (spans too wide)vi. Lack of bonding between old and newly added walls	Physical inspection and occupants account
Cracked cementious screed floor	<ul style="list-style-type: none">i. Use of cementious screed only instead of mass concrete.	Physical inspection
Basal erosion	Cementious rendering, lack of roof guttering and site drainage.	Physical inspection

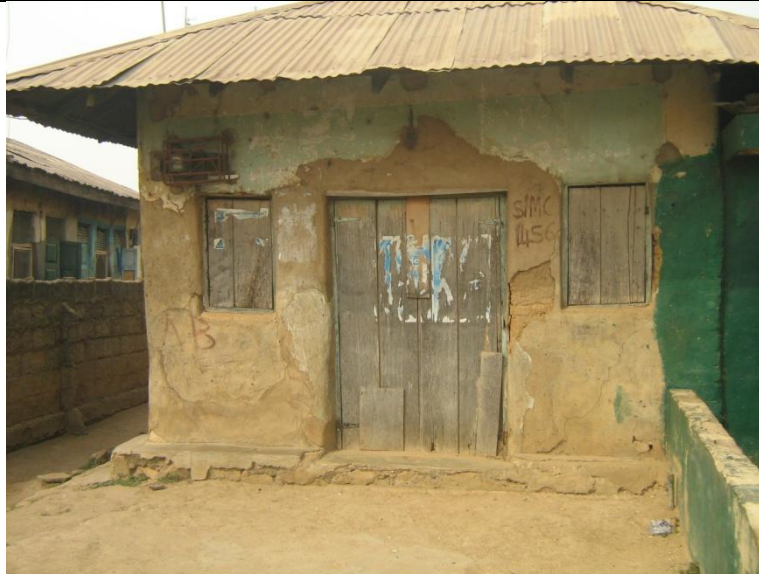
Building No: 13

Defects	Possible causes	Survey method / Evidence
Cracked cementious render	<ul style="list-style-type: none">i. Incompatibility of cementious rendering and adobe.ii. Remodellingiii. Introduction of burglar proofs and mosquito nets	Physical inspection and occupants account
Cracked adobe walls	<ul style="list-style-type: none">i. Incompatibility of cementious rendering and adobe.ii. Remodellingiii. Introduction of burglar proofs and mosquito netsiv. Failure of timber lintels due to the span of the doors and windows (spans too wide)v. Lack of bonding between old and newly added walls	Physical inspection and occupants account
Cracked cementious screed floor	<ul style="list-style-type: none">i. Use of cementious screed instead of mass concrete.ii. Underground moisture (capillary action) due to cracking of cementious floor screed	Physical inspection
Basal erosion	Cementious rendering, lack of roof guttering and site drainage.	Physical inspection

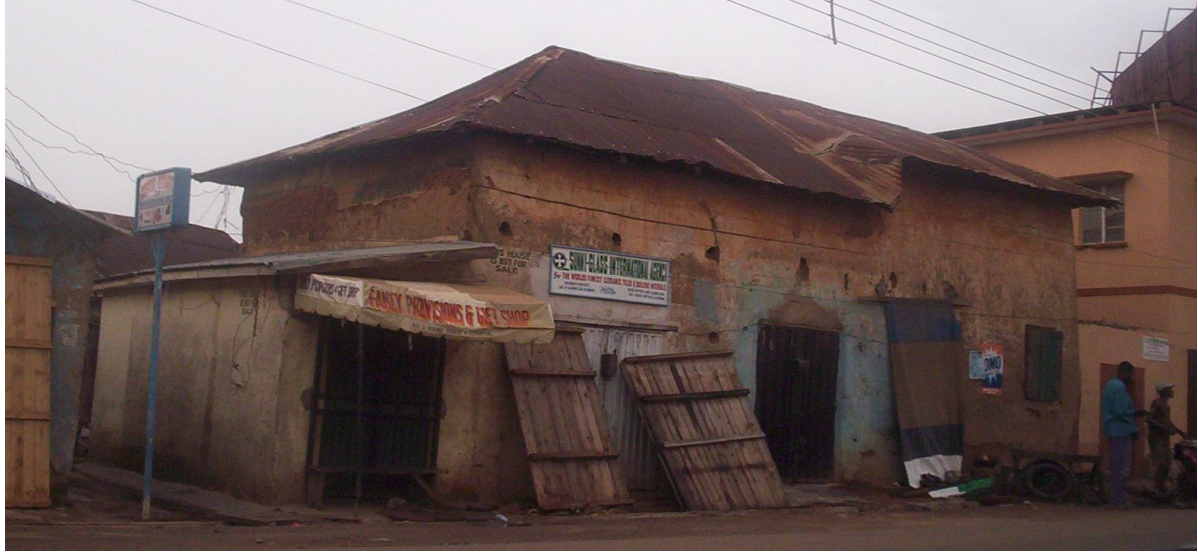
Building No: 14

Defects	Possible causes	Survey method / Evidence
Sagged roof	Ageing and lack of maintenance	Physical inspection
Cracked cementious render	i. Incompatibility of cementious rendering and adobe. ii. Remodelling iii. Introduction of burglar proofs and mosquito nets iv. Use of walls for signage (products advertisement) v. Erection of entrance canopy	Physical inspection
Cracked adobe walls	i. Incompatibility of cementious rendering and adobe. ii. Remodelling iii. Introduction of burglar proofs and mosquito nets iv. Use of walls for signage (products advertisement) v. Erection of entrance canopy vi. Failure of timber lintels due to the span of the doors and windows (spans too wide) vii. Lack of bonding between old and newly added walls	Physical inspection and occupants account
Cracked cementious screed floor	Use of cementious screed instead of mass concrete.	Physical inspection and occupants account

Damp	i. Cementious render ii. Application of oil paint iii. Inappropriate remodelling v. Lack of ventilation vi. Underground moisture (capillary action) due to cracking of cementious floor screed. vii. Flooding caused by road rehabilitation	Physical inspection and occupants account
Basal erosion	Cementious rendering, lack of roof guttering and site drainage.	Physical inspection and occupants account

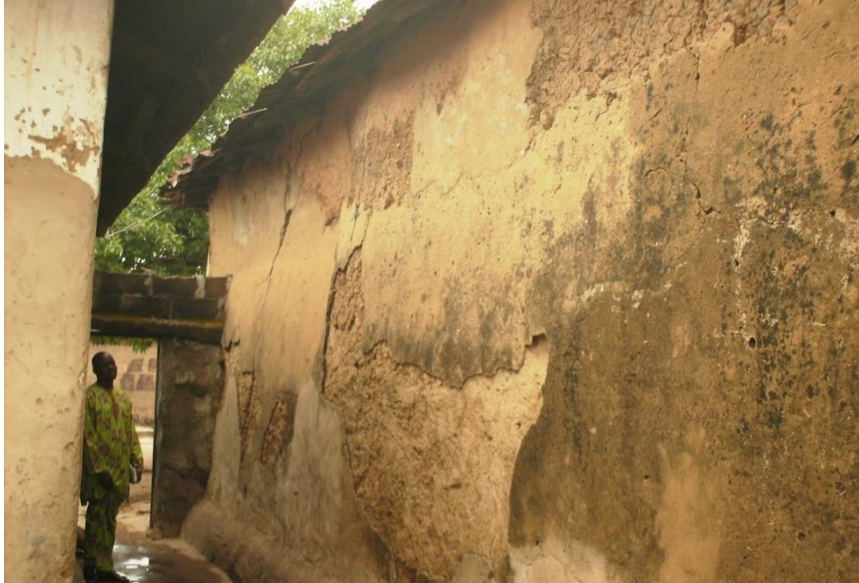
Building No: 15

Defects	Possible causes	Survey method / Evidence
Cracked cementious render	<ul style="list-style-type: none">i. Incompatibility of cementious rendering and adobe.ii. Remodellingiii. Rain water from the roof of the adjoining a building in the adjoining compound	Physical inspection
Cracked adobe walls	<ul style="list-style-type: none">i. Inappropriate remodellingii. New electrical wiringiii. Introduction of burglary proofs and mosquito's screensiv. Lack of bonding between old and newly added walls	Physical inspection
Cracked cementious screed floor	Use of cementious screed instead of mass concrete.	Physical inspection and occupants account
Damp	<ul style="list-style-type: none">i. Cementious renderii. Inappropriate remodellingiii. Lack of ventilationiv. Underground moisture (capillary action) due to cracking of cementious floor screedv. Rain water from the roof of the adjoining a building in the adjoining compound.	Physical inspection and occupants account

Basal erosion	Cementious rendering, lack of roof guttering and site drainage.	Physical inspection and occupants account

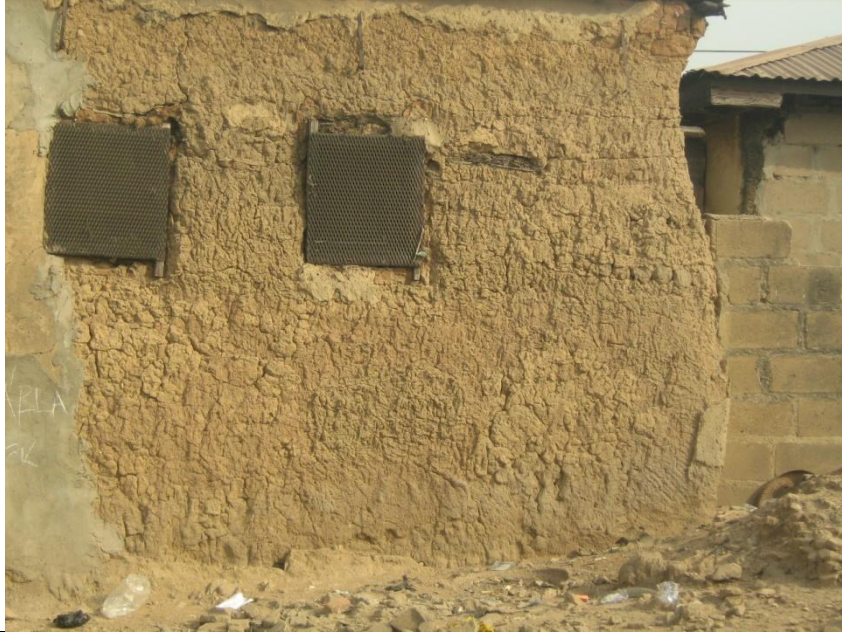
Building No: 16

Defects	Possible causes	Survey method / Evidence
Eroded earth based render	<ul style="list-style-type: none"> i. Inadequate roof overhang ii. Neglect and lack of maintenance iii. Introduction burglary proof and mosquito's nets screens iv. Incompatibility of concrete block used for the construction of the adjoining building 	Physical inspection
Cracked adobe walls	<ul style="list-style-type: none"> i. Inadequate roof overhang ii. Neglect and lack of maintenance iii. Introduction burglary proof and mosquito's nets screens iv. Lack of bond between the concrete blocks used for the construction of the adjoining building. 	Physical inspection
Cracked cementious screed floor	<ul style="list-style-type: none"> i. Use of cementious screed instead of mass concrete. ii. Underground moisture (capillary action) due to cracking of cementious floor screed 	Physical inspection
Basal erosion	Cementious rendering, lack of roof guttering and site drainage.	Physical inspection and occupants account

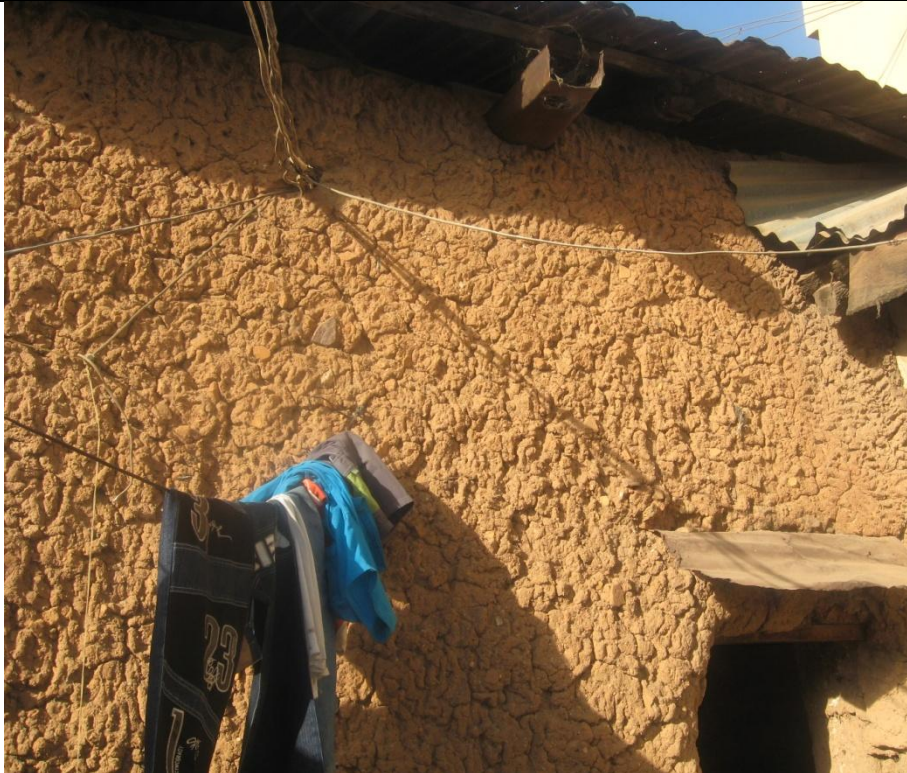
Building No: 17

Defects	Possible causes	Survey method / Evidence
Eroded earth based render	<ul style="list-style-type: none">i. Inadequate roof overhangii. Neglect and lack of maintenanceiii. Inappropriate remodellingiv. Incompatibility of concrete block used for the construction of the adjoining buildingv. Misuse	Physical inspection and occupants account
Cracked adobe walls	<ul style="list-style-type: none">i. Inadequate roof overhangii. Neglect and lack of maintenanceiii. Inappropriate remodellingiv. Incompatibility of concrete block used for the construction of the adjoining buildingv. Misusevi. Introduction of burglary proofs and mosquito's screensvii. Lack of bonding between old and newly added walls	Physical inspection and occupants account
Cracked cementious screed floor	<ul style="list-style-type: none">i. Use of cementious screed instead of mass concrete.	Physical inspection and occupants account

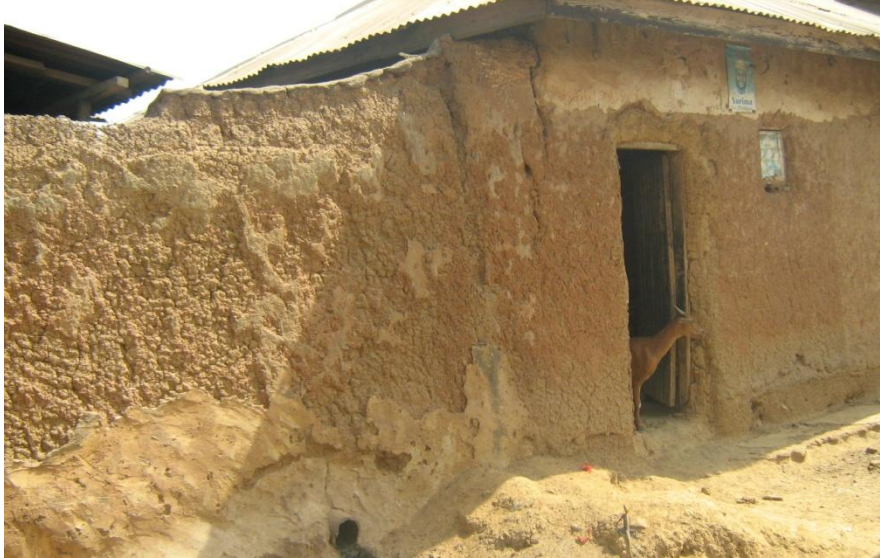
Building No: 18

Defects	Possible causes	Survey method / Evidence
Cracked cementious render	<ul style="list-style-type: none"> i. Incompatibility of cementious rendering and adobe. ii. Inappropriate remodelling iii. Neglect and lack of maintenance iv. abrasion caused human and animal (goats) movements 	Physical inspection and occupants account
Cracked adobe walls	<ul style="list-style-type: none"> i. Incompatibility of cementious rendering and adobe. ii. Inappropriate remodelling iii. Neglect and lack of maintenance iv. abrasion caused human and animal (goats) movements v. Introduction of burglary proofs and mosquito's screens vi. Lack of bonding between old and newly added walls 	Physical inspection and occupants account
Cracked cementious screed floor	Use of cementious screed instead of mass concrete.	Physical inspection and occupants account
Damp	<ul style="list-style-type: none"> i. Inappropriate remodelling ii. Lack of ventilation iii. Underground moisture (capillary action) due to cracking of cementious floor screed 	Physical inspection and occupants account

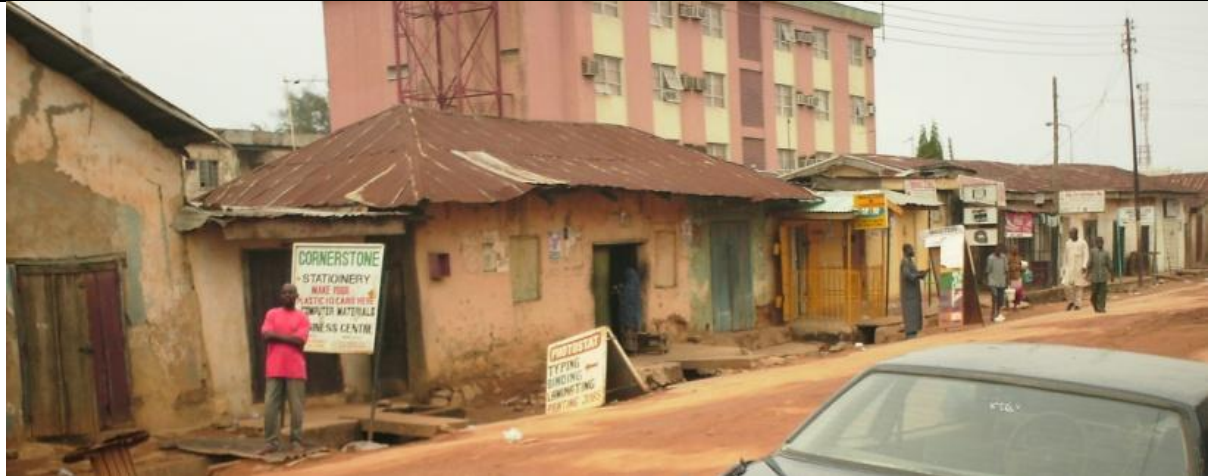
Buildings No: 19 and 20

Defects	Possible causes	Survey method / Evidence
Cracked cementious render	<ul style="list-style-type: none"> i. Incompatibility of cementious rendering and adobe. ii. Inappropriate remodelling iii. Neglect and lack of maintenance iv. Introduction of entrance canopies v. Use of walls as signage for products and services advertisements 	Physical inspection and occupants account
Cracked adobe walls	<ul style="list-style-type: none"> i. Incompatibility of cementious rendering and adobe. ii. Inappropriate remodelling iii. Neglect and lack of maintenance iv. Introduction of entrance canopies v. Use of walls as signage for products and services advertisements vi. Failure of timber lintels due to the span of the doors and windows (spans too wide) in building number 08 vii. Introduction of burglary proofs and mosquito's screens viii. Lack of bonding between old and newly added walls 	Physical inspection and occupants account

Damp walls and floors	<ul style="list-style-type: none"> i. Incompatibility of cementious rendering and adobe. ii. Inappropriate remodelling iii. Neglect and lack of maintenance iv. Introduction of entrance canopies v. Use of walls as signage for products and services advertisements vi. Lack of ventilation vii. Underground moisture (capillary action) due to cracking of cementious floor screed viii. Moisture from water leaking from the plumbing pipes in buildings number 19 and 20 	Physical inspection and occupants account
Cracked cementious screed floor	Use of cementious screed instead of mass concrete.	Physical inspection and occupants account
Basal erosion	Cementious rendering, lack of roof guttering and site drainage.	Physical inspection and occupants account
